**FINAL DESKTOP STUDY
AND PRELIMINARY
REGIONAL CONCEPTUAL
SITE MODEL**

**FISHERMANS BEND
EMPLOYMENT
PRECINCT**

Client: Environment Protection Authority Victoria

AECOM Australia Pty Ltd

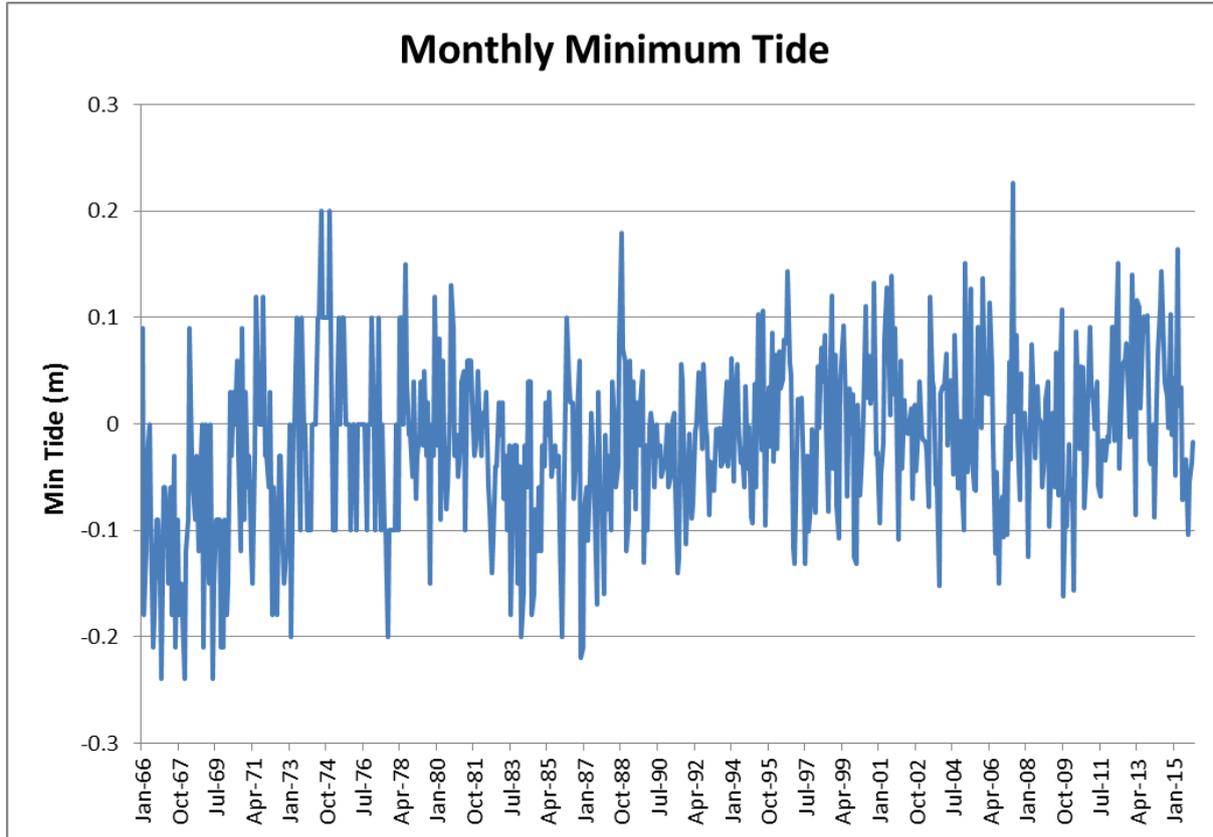
Graph 1 Monthly Minimum Tide between 1966 and 2015

- The highest of the minimum tide heights was 0.227 MASL, which occurred in May 2007.
- The average monthly sea level is 0.554 m.

Graphs 1 to 2 below depict the Monthly Minimum Tides and Monthly Maximum Tides between 1966 and 2015.

Based on the data presented above in relation to tidal variation (up to 0.759 MASL), the elevation of the precinct (0 - >4 mAHD) and the anticipated average depth of groundwater (approximately 3 mBGL, based on the results of groundwater sampling across the other four precincts), we would expect that tides would increase and decrease the groundwater elevation at the precinct.

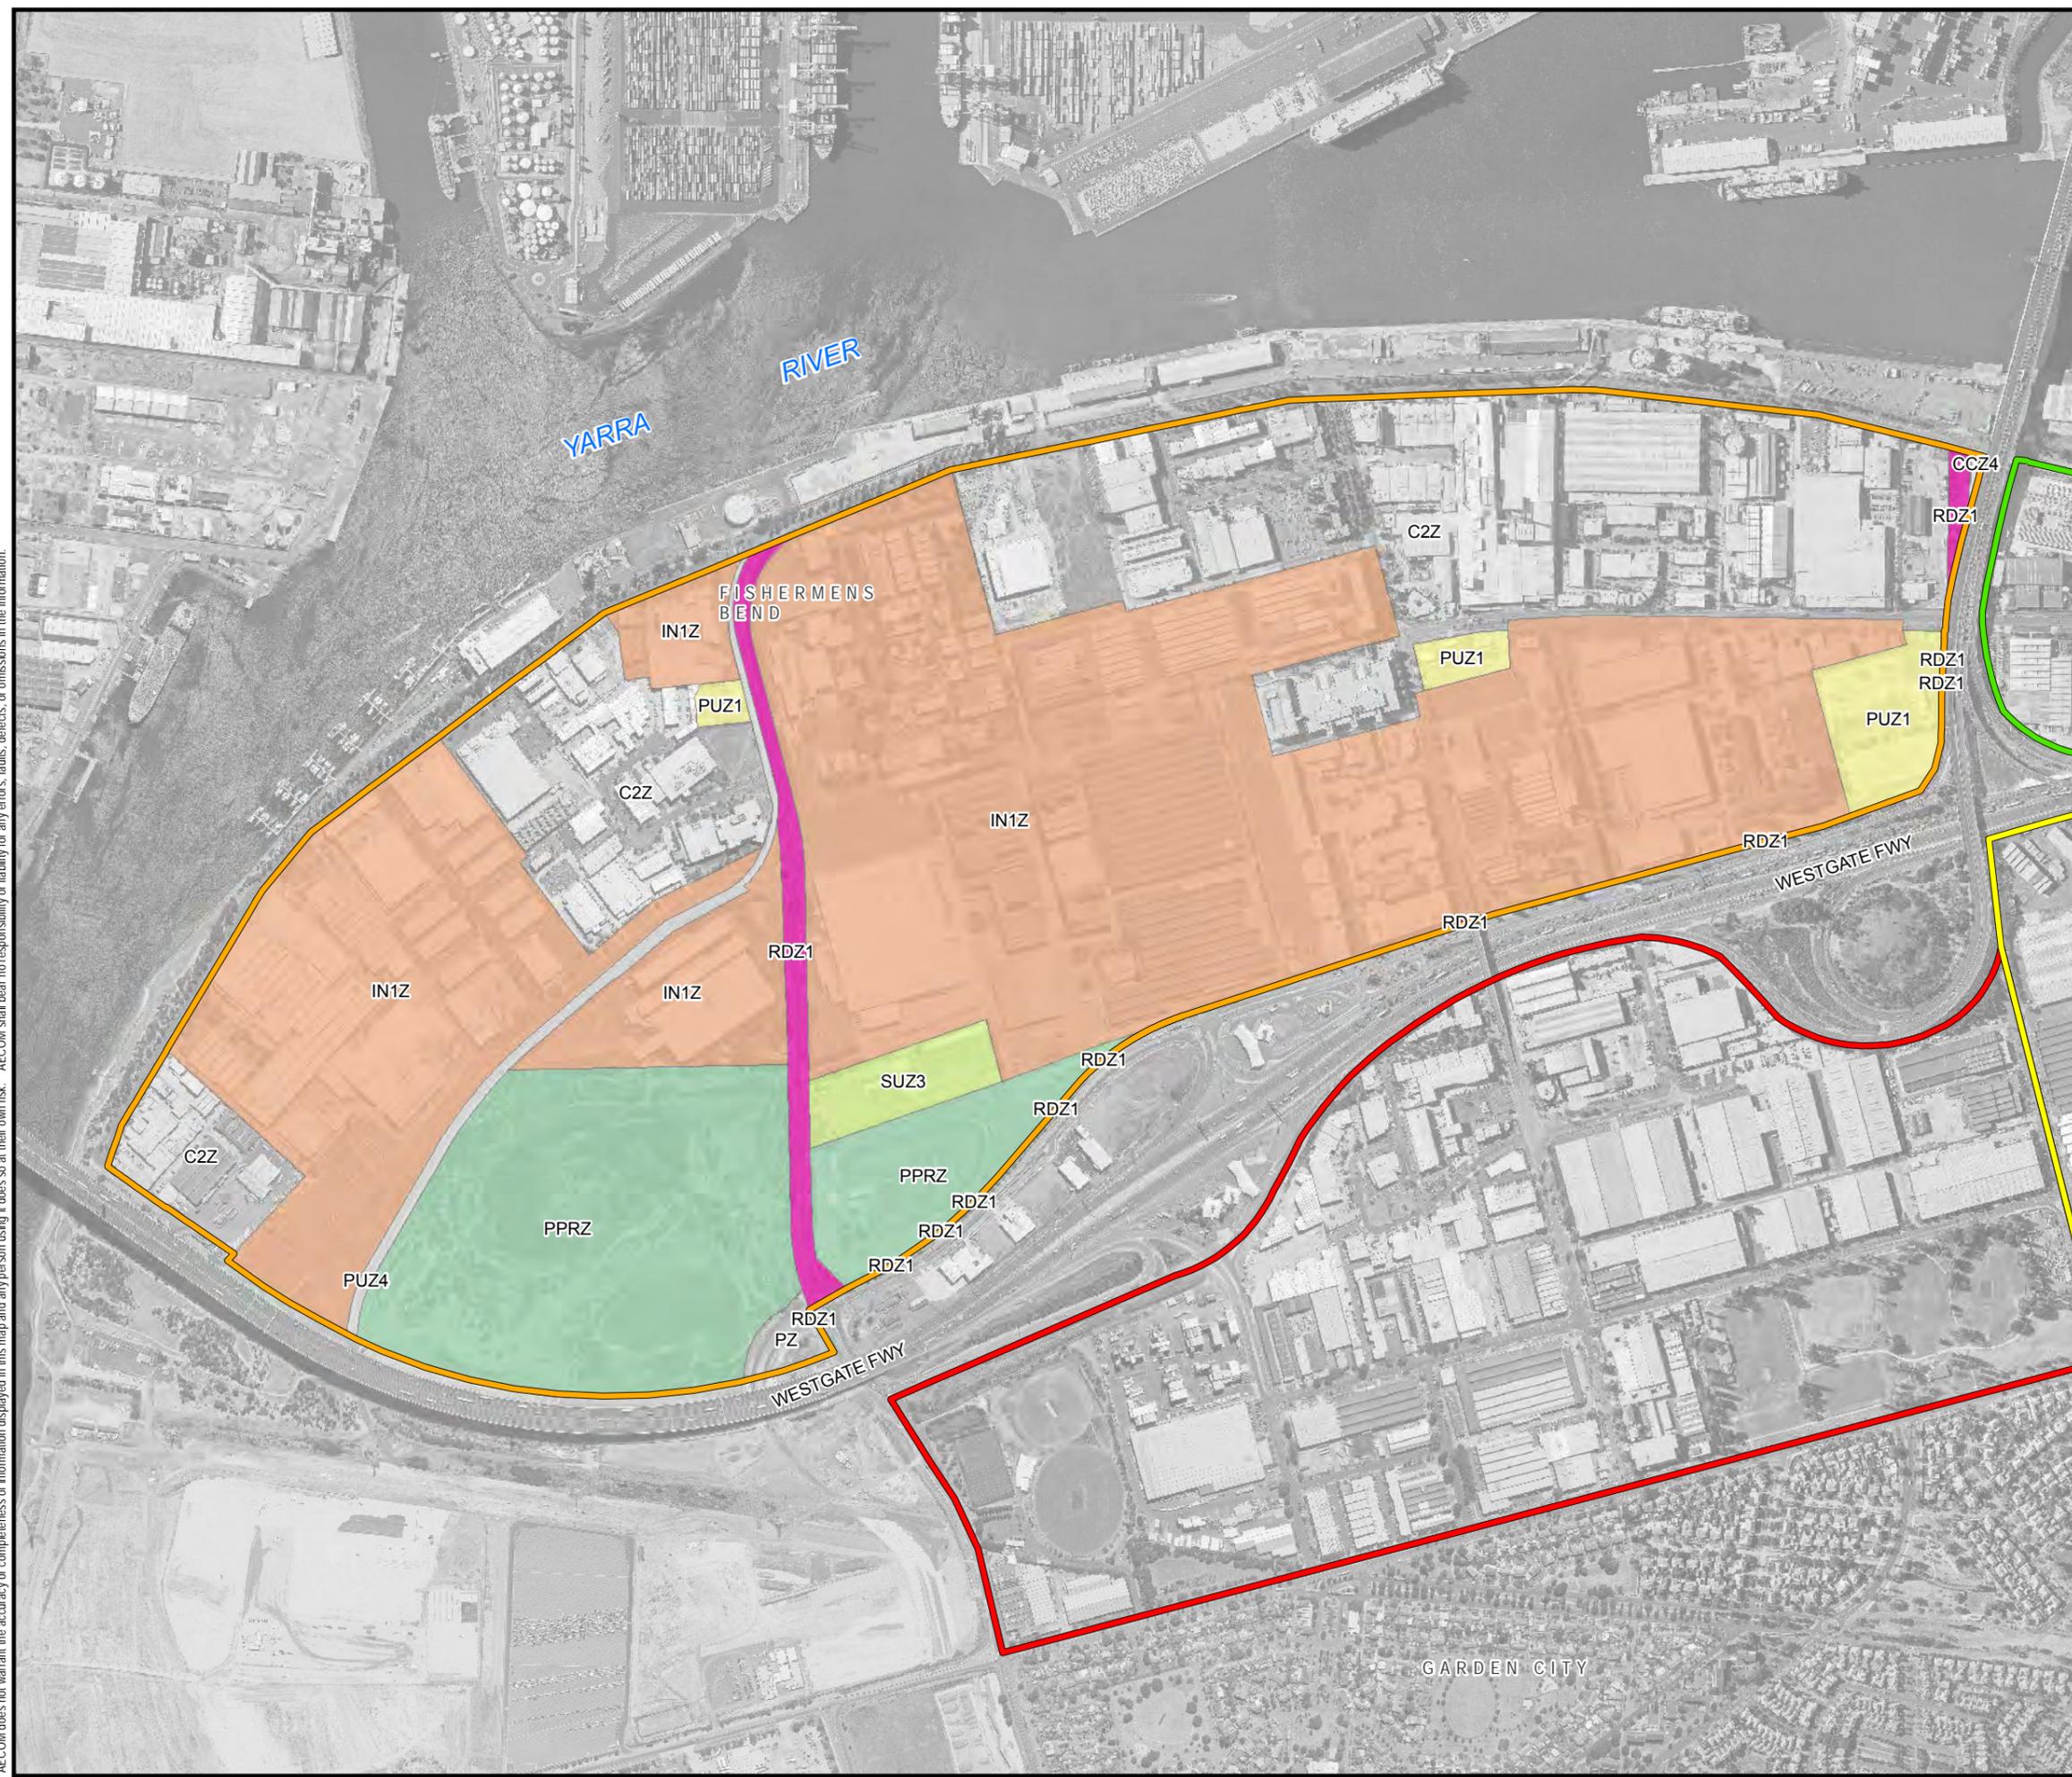
<p>EPA 2017 Employment Desktop Study Fisherman's Bend, Port Melbourne, VIC</p>	<p>Figure F2</p>
---	------------------------------

CURRENT PLANNING ZONES

The precinct is generally used for heavy and light commercial and industrial processes which are described further in **Section 4.1**. The following table summarises the relevant precinct details. Please refer to **Figure F2** for the current zoning and **Figure F3a** and **F3b** for overlay conditions across the precinct.

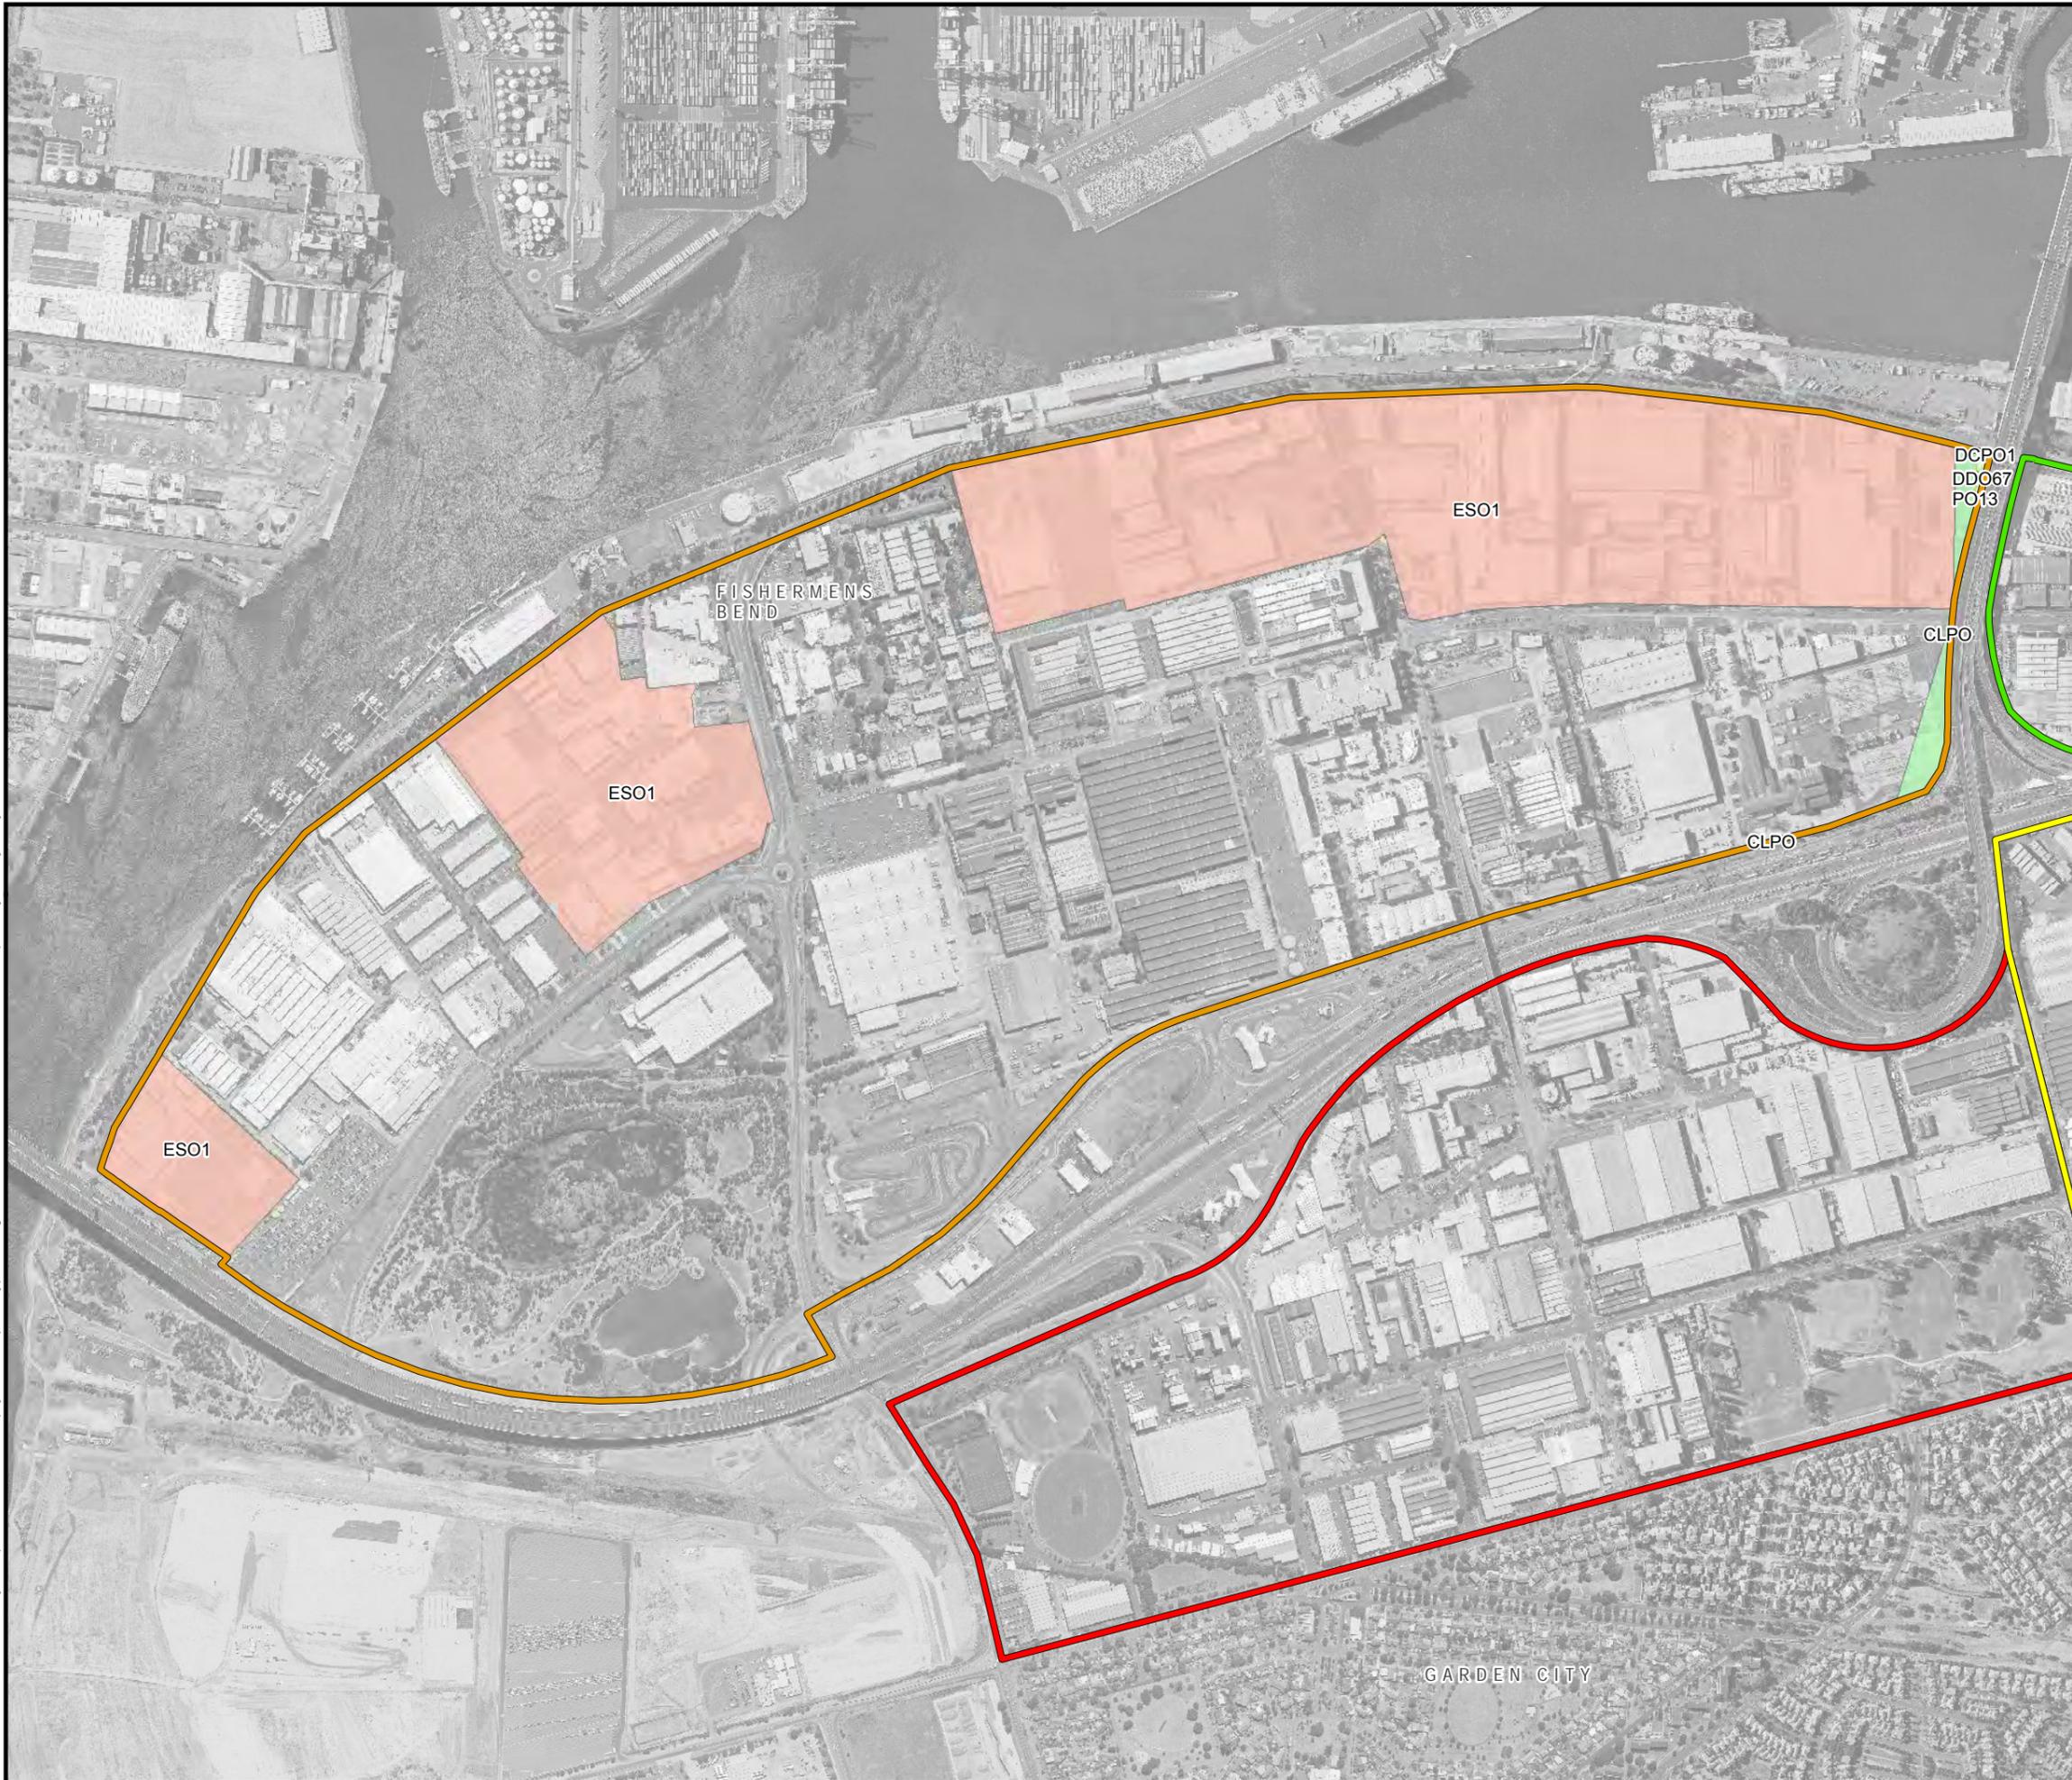
CURRENT PLANNING OVERLAYS

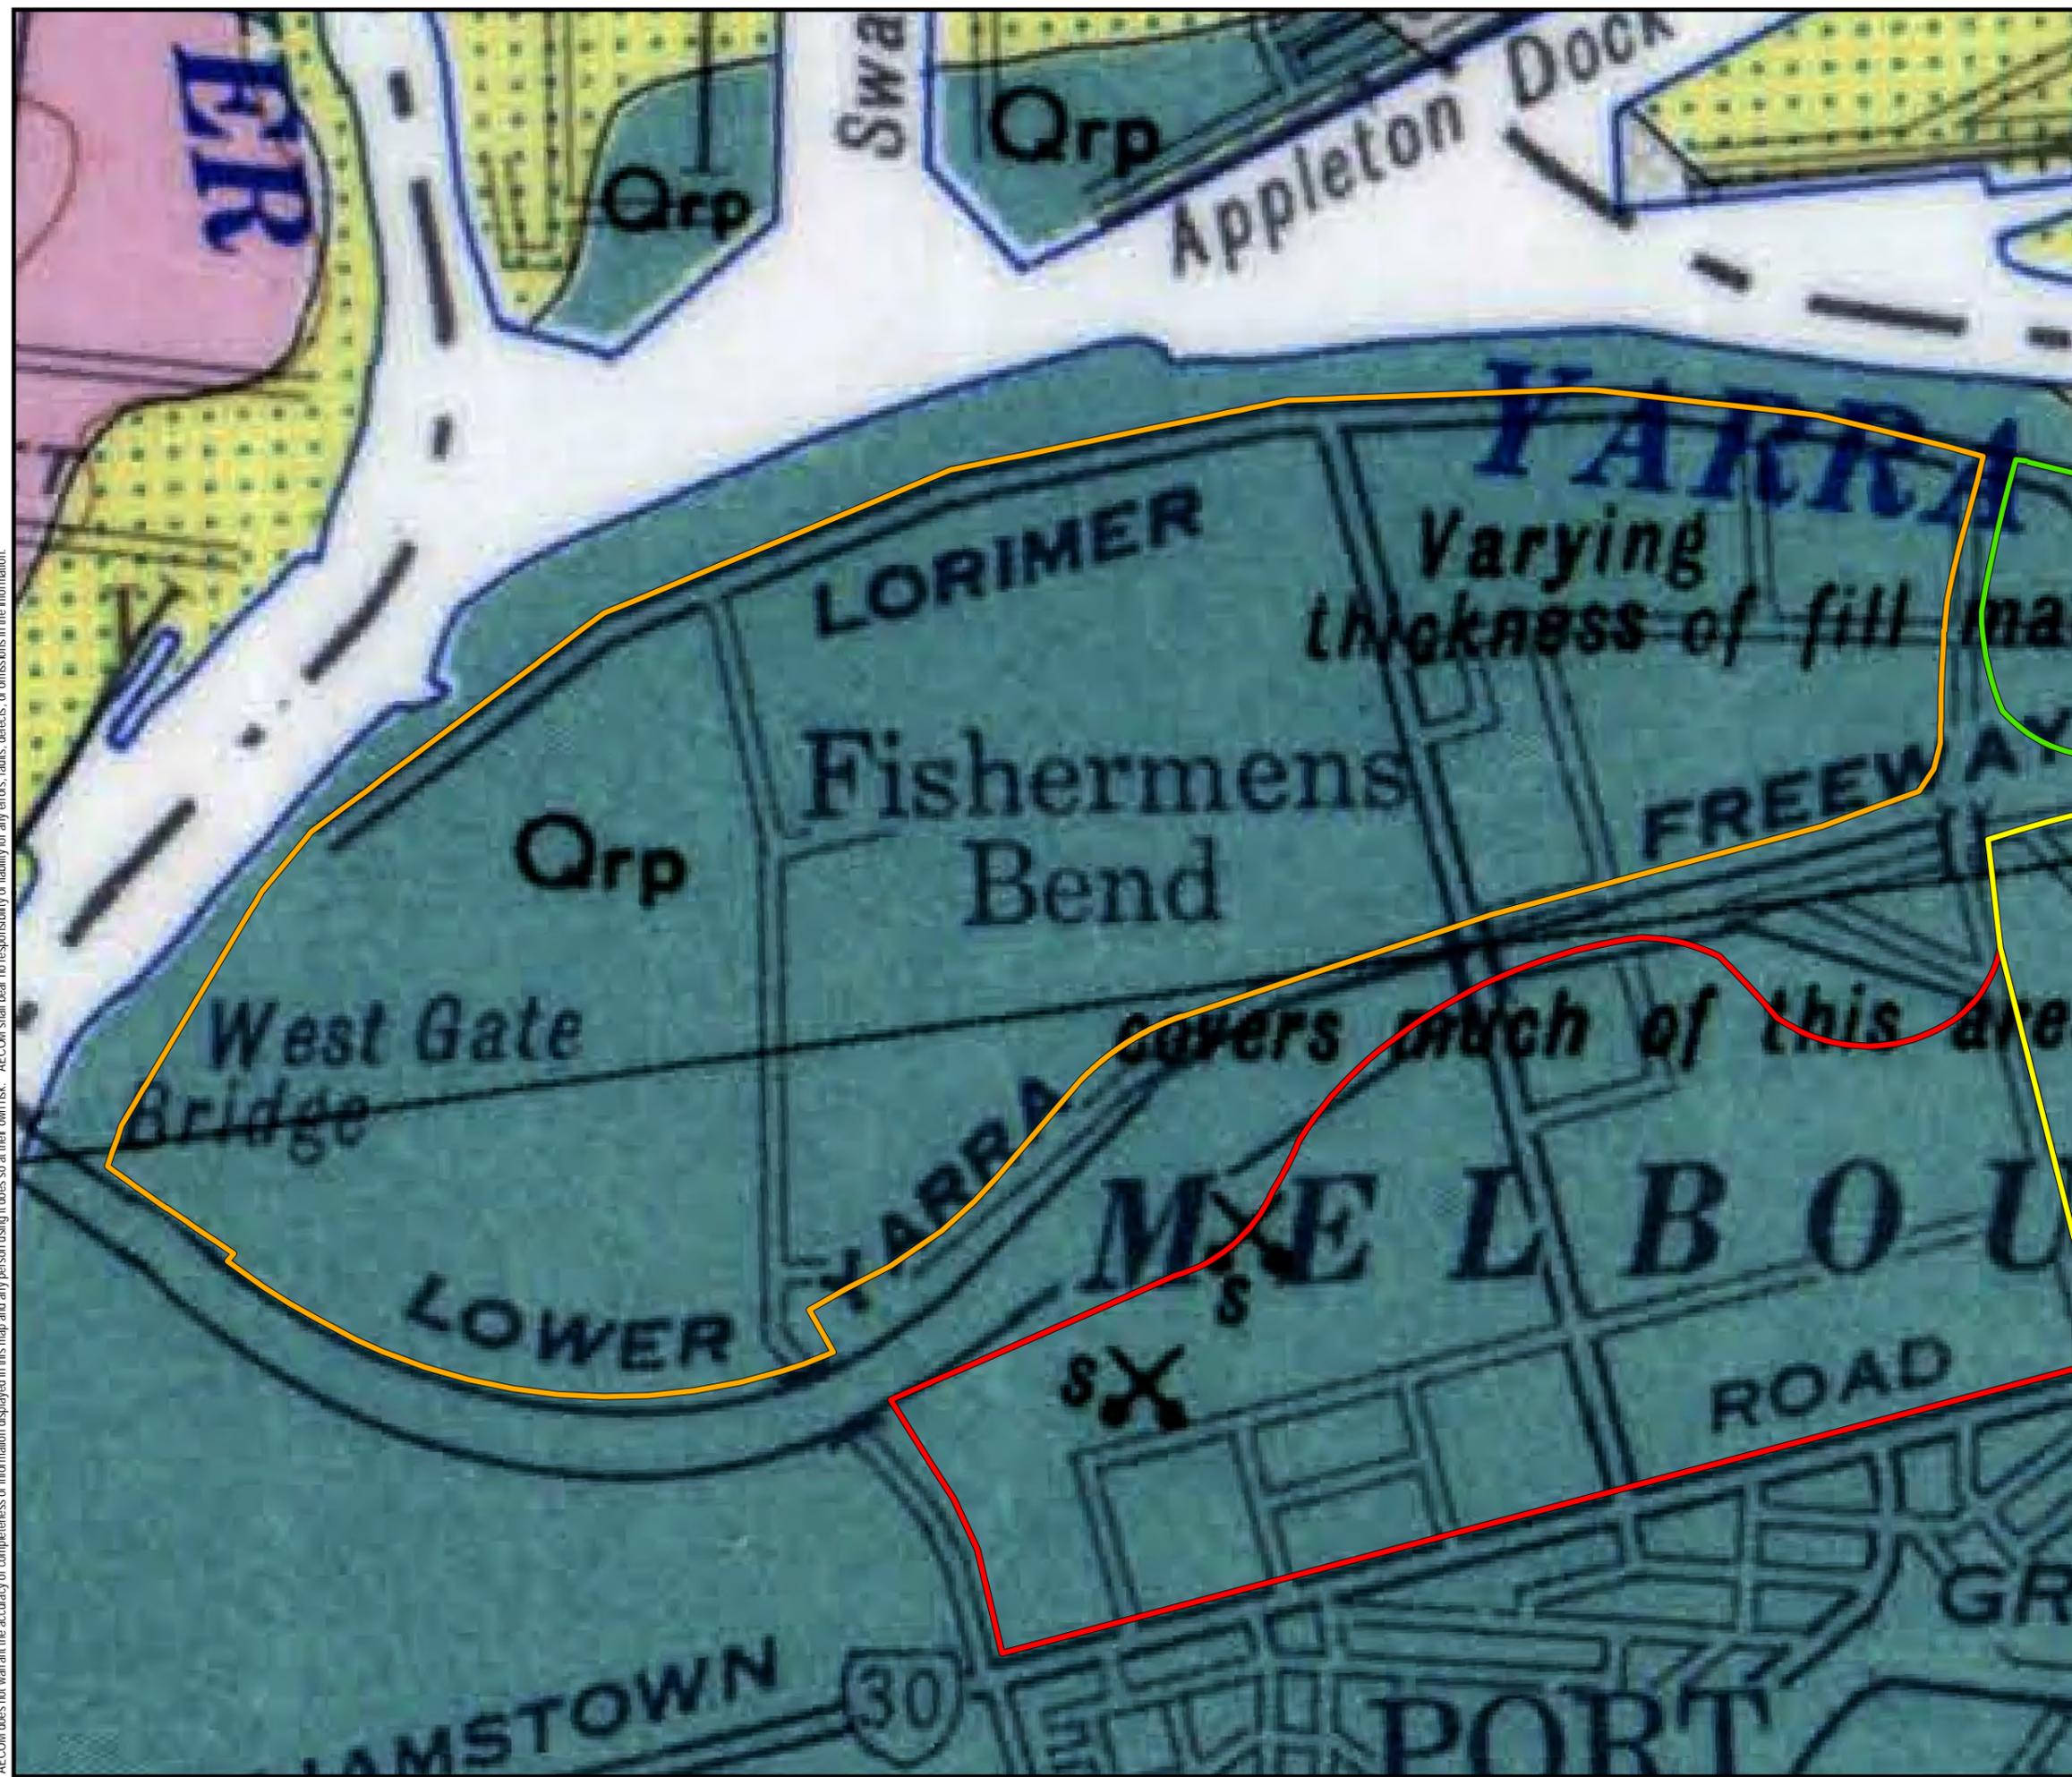
- NEWER VOLCANICS**
- Qrp** Raised beach ridges: bedded and cross bedded well sorted sand, shelly sand, minor silty or clayey sand
 - Qrs** Coastal swamp deposits: fine sand, silt, silty clay often with shell beds
 - Qri** Silt, silty clay, sandy clay, dark grey, minor peat and shell beds

- Coode Island Silt (Qri) which is described as silt, silty clay, sandy clay dark grey with minor peat and shell beds.
- The pleistocene aged Fishermans Bend Silt (Qpf) described as silty clay, pale grey to pale brown, with some minor sandy clay and silt the upper part of the formation is mottled and fissured.
- The pleistocene aged Moray Street Gravel (Qpg) described as quartz gravel and sand, with minor silt, clay and carbonaceous clay.
- The tertiary aged Newport Formation (Tmn) described as silt, grey and green, with calcareous silt, silty clay and minor limestone.
- Miocene aged Older Volcanics (Tvo) described as dense blue / black basalt.
- The Eocene aged Werribee Sand (Tew) described as sand, sandy and silty clay, with pyritic and lignitic quartz sand.

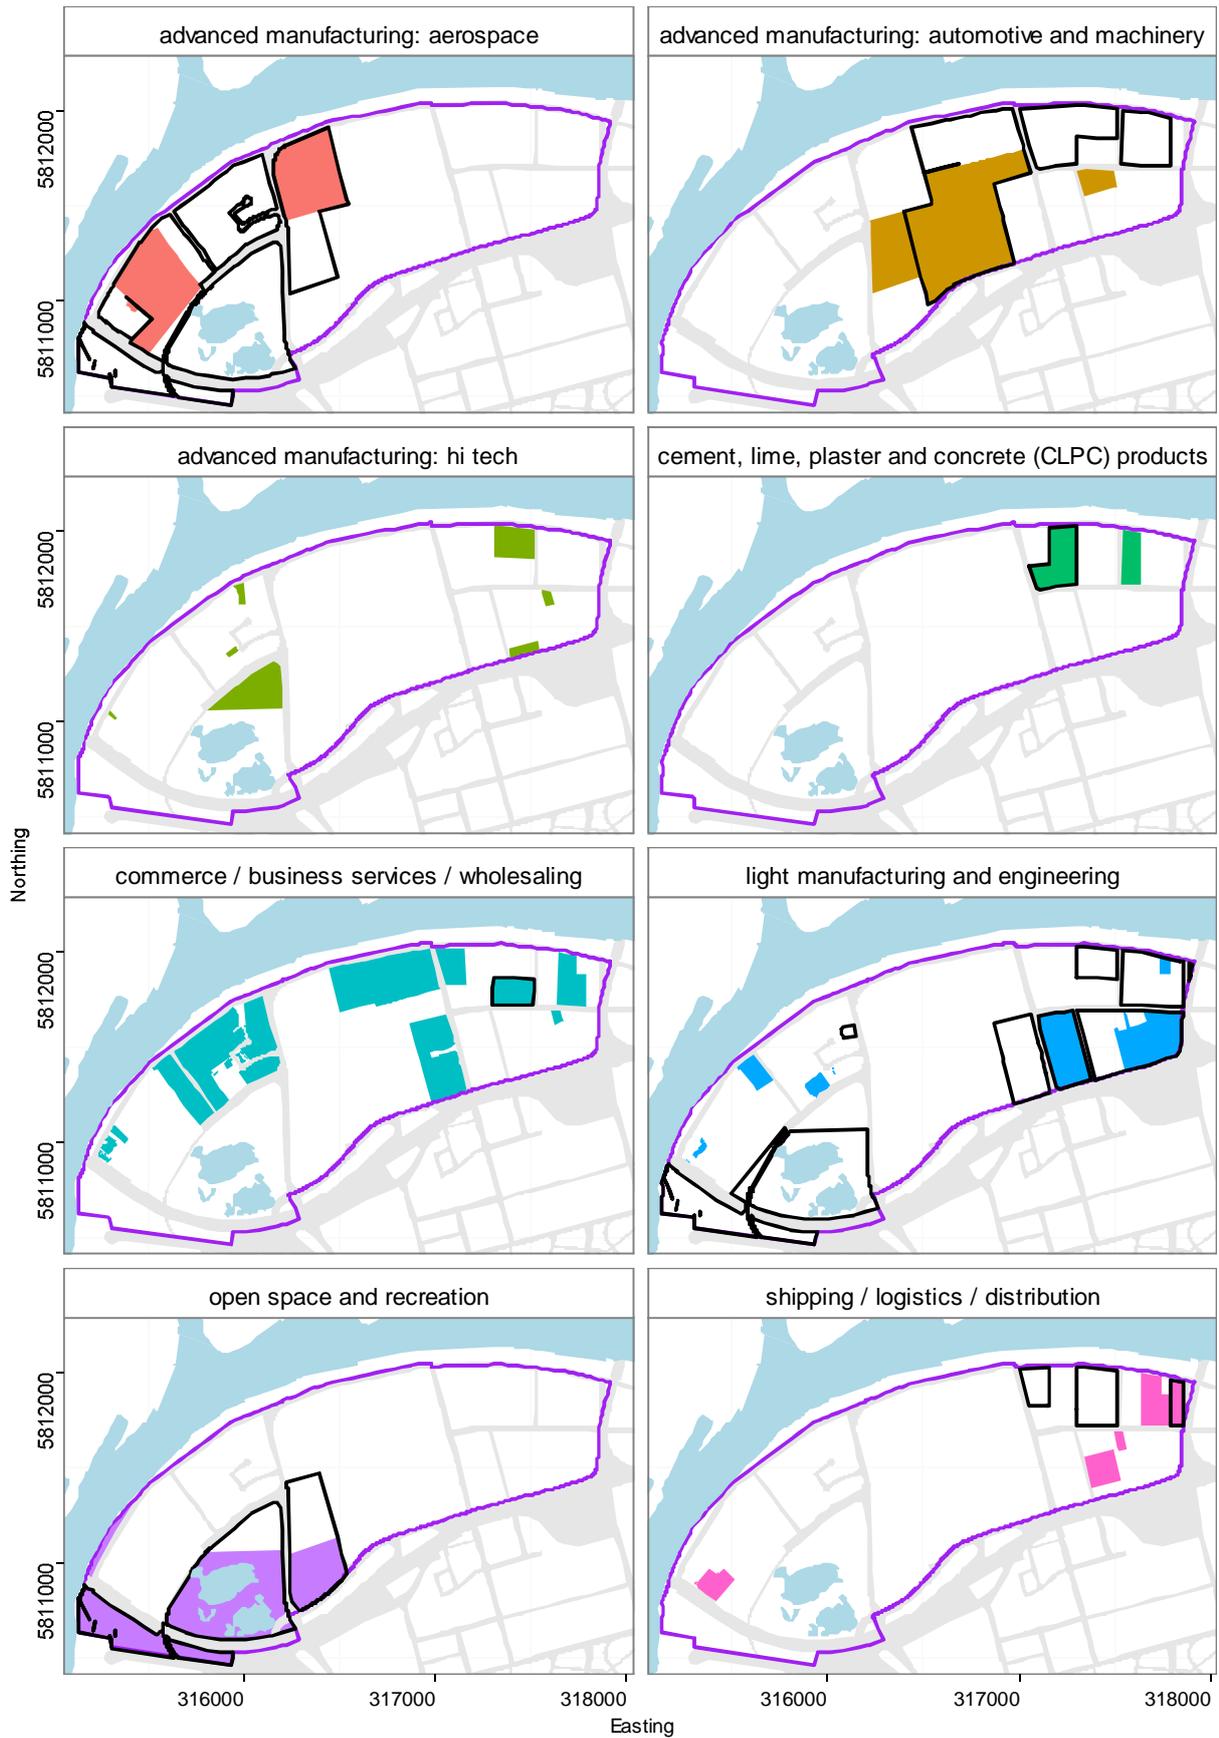
Figure 37: Location of industry footprint in Fisherman's Bend Precinct showing a) past land use (black border) and b) present land use (filled area). Study Area boundary shown with Employment Precinct in purple.

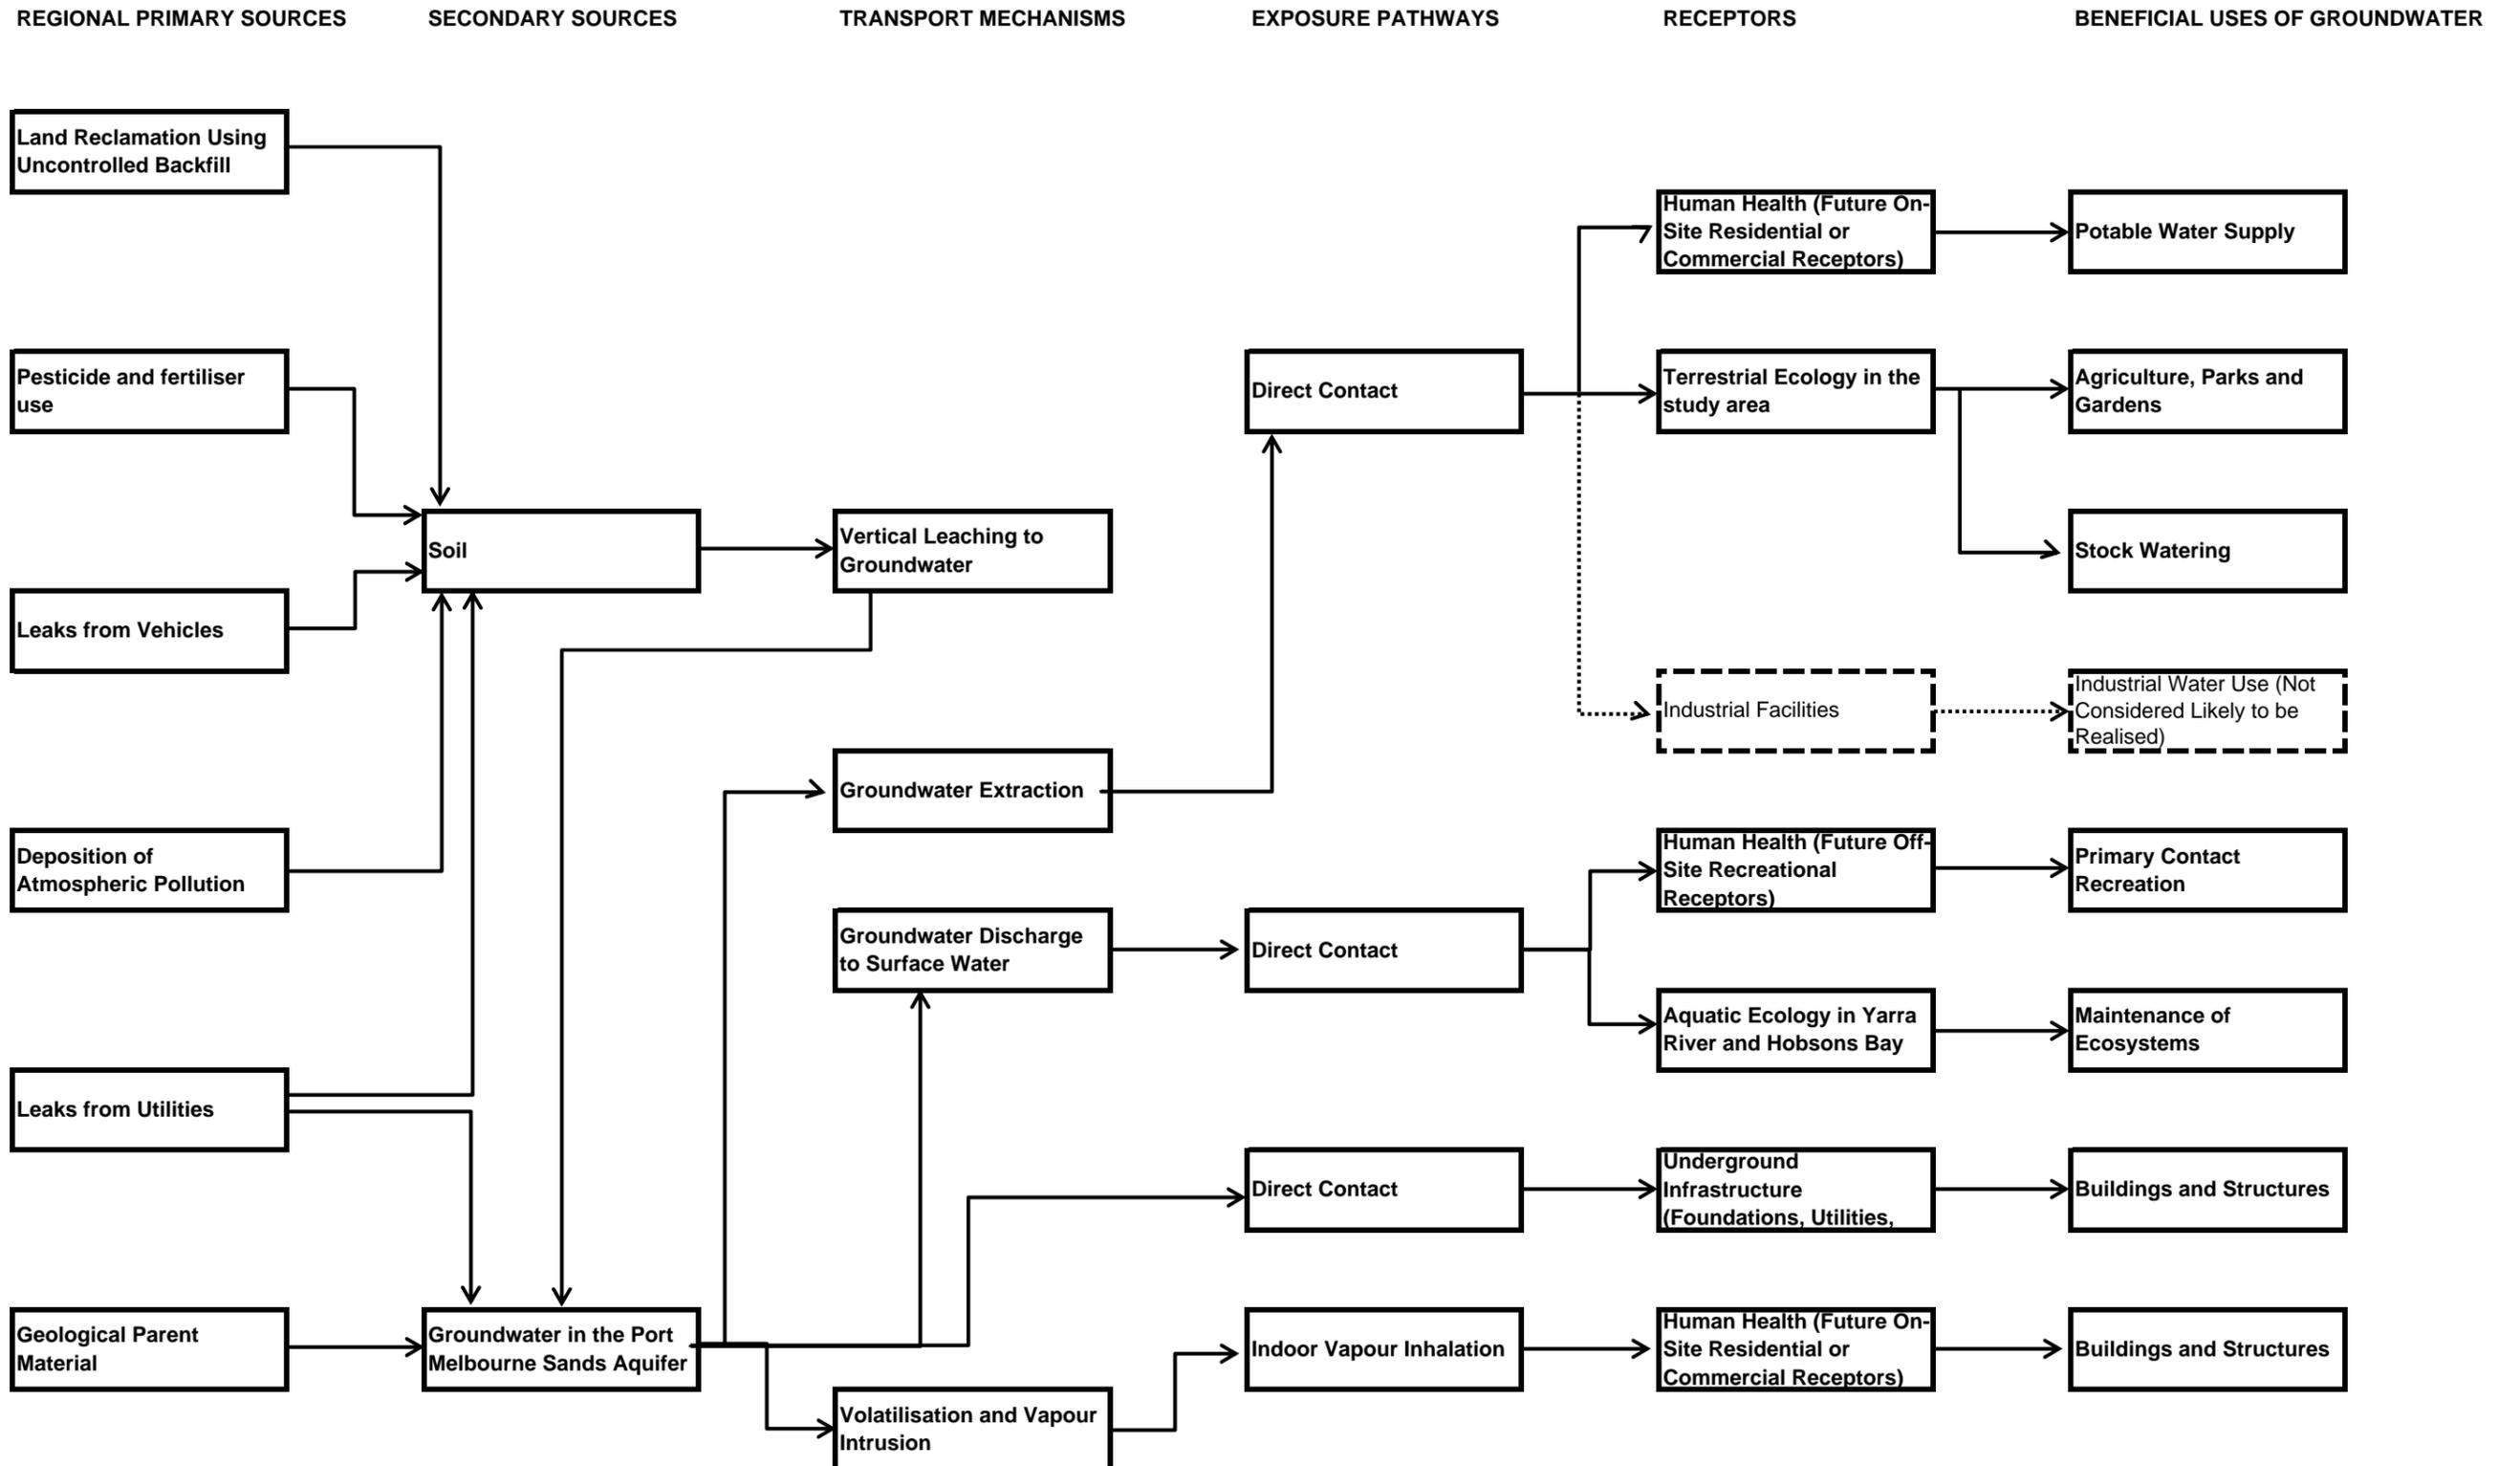
Preliminary Regional Conceptual Site Model

Note: Site Specific Sources are excluded.
