**327 Yan Yean Road, Plenty, VIC**

Title:	Preliminary Risk Screen Assessment at 327 Yan Yean Road, Plenty, VIC
Report no:	221086_PRSA_V
Date:	10/12/2021

# PRELIMINARY RISK SCREEN ASSESSMENT AT 327 YAN YEAN ROAD, PLENTY, VICTORIA HWL EBSWORTH LAWYERS

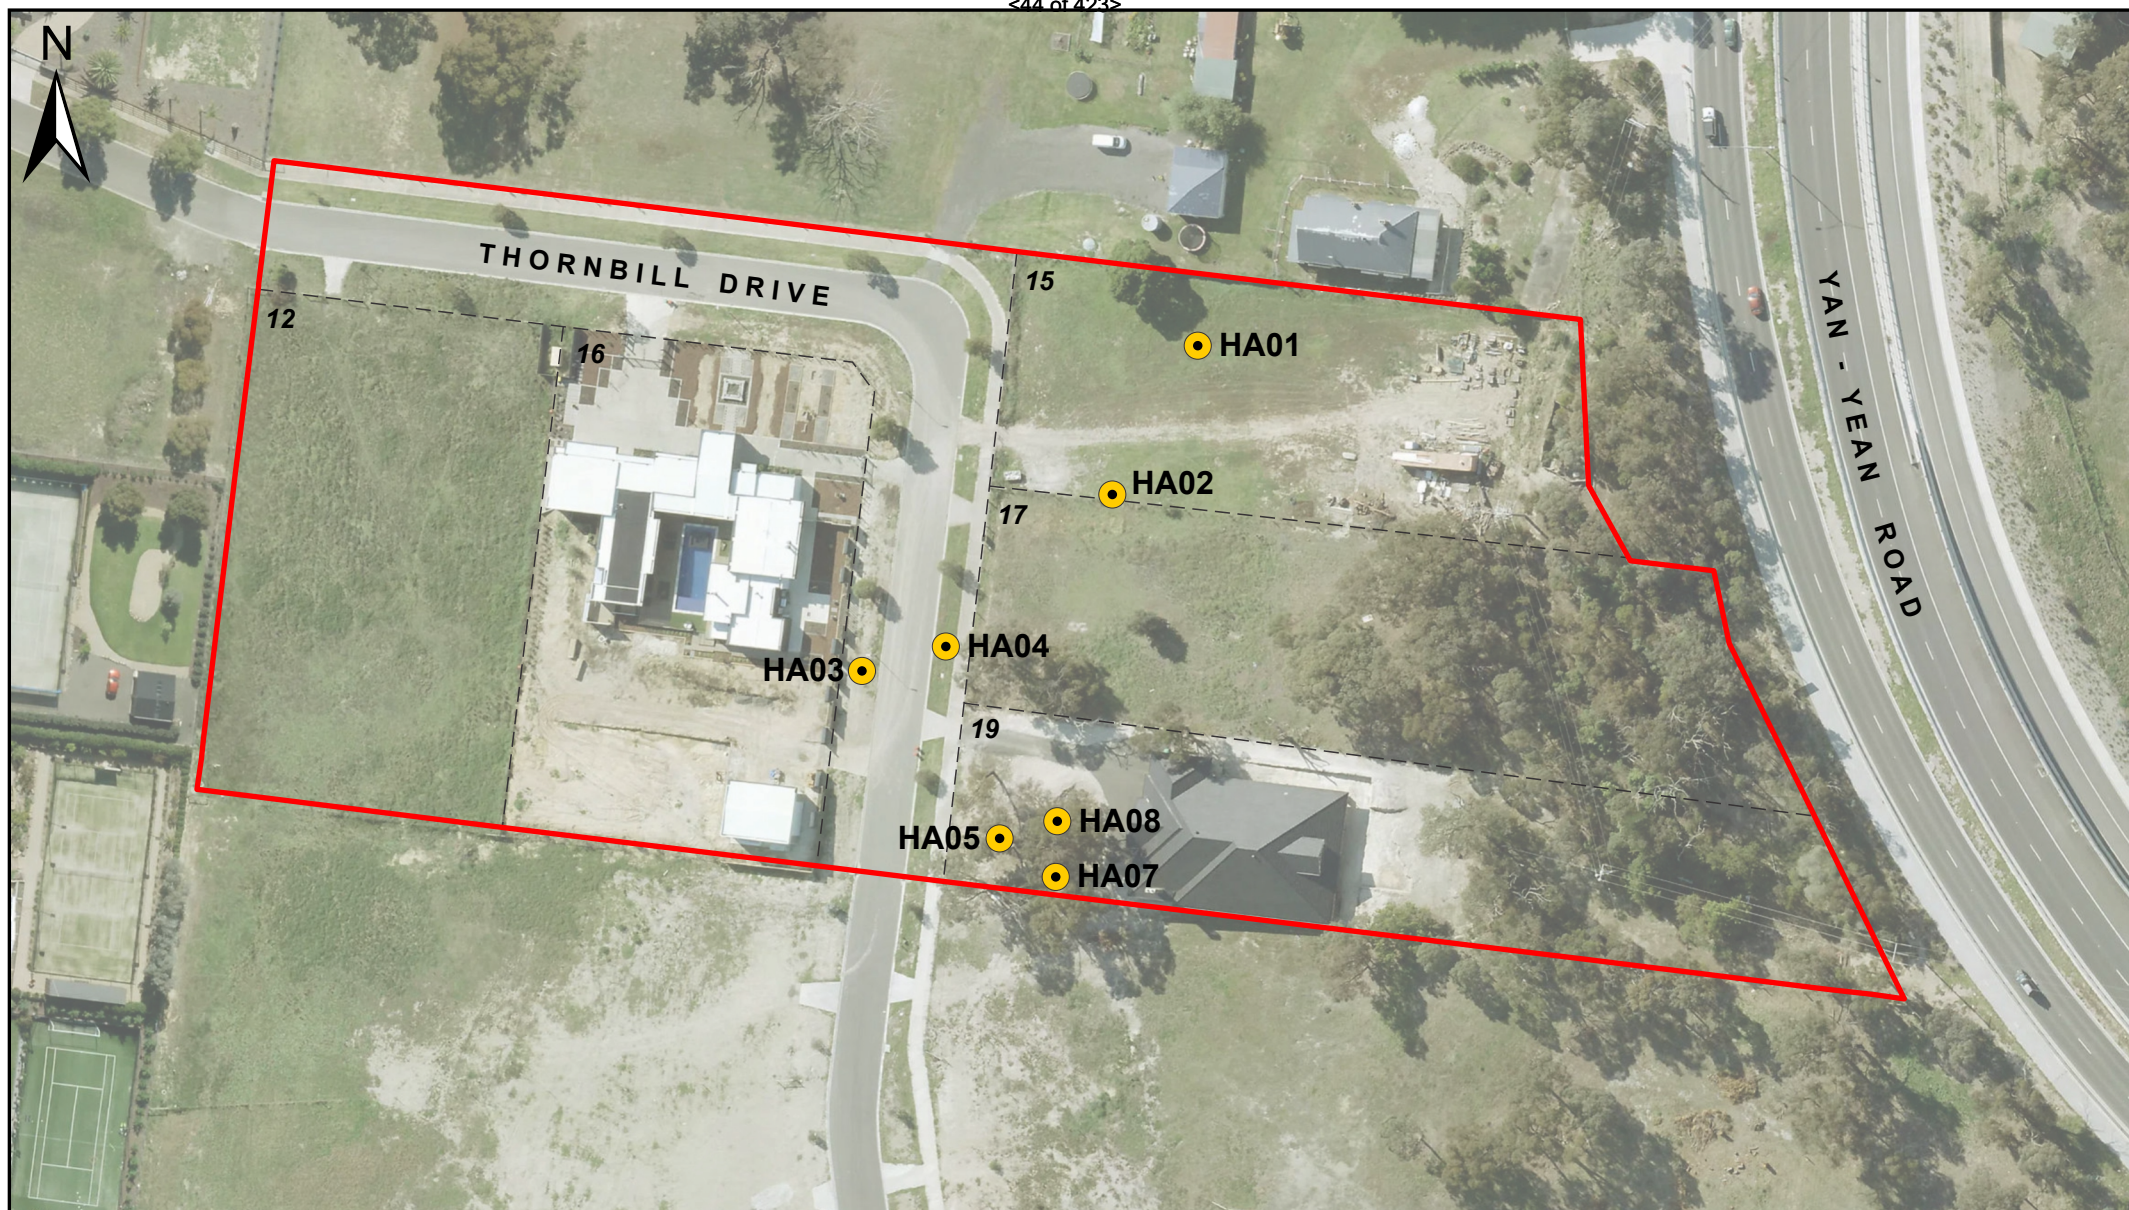
Figure 1: Site location and PRSA boundary

The regional location and PRSA boundary are shown in **Figure 1**, and the proposed development plans provided in **Appendix A**.

The site is formerly known as 327 Yan Yean Road, which now consists of 5 lots (No. 12, 15, 16, 17, 19) and Thornbill Drive. The site is currently subdivided with houses on No 16 and 19; No. 12, 15, and 17 are undeveloped. The site identification details are summarised in **Table 3 below** and the site locality and layout are presented in **Figure 1** (Figures Appendix).

Nillumbik Shire Council's landfill located at 290-304 Yan Yean Road (see **Figure 1** and **Appendix C**).

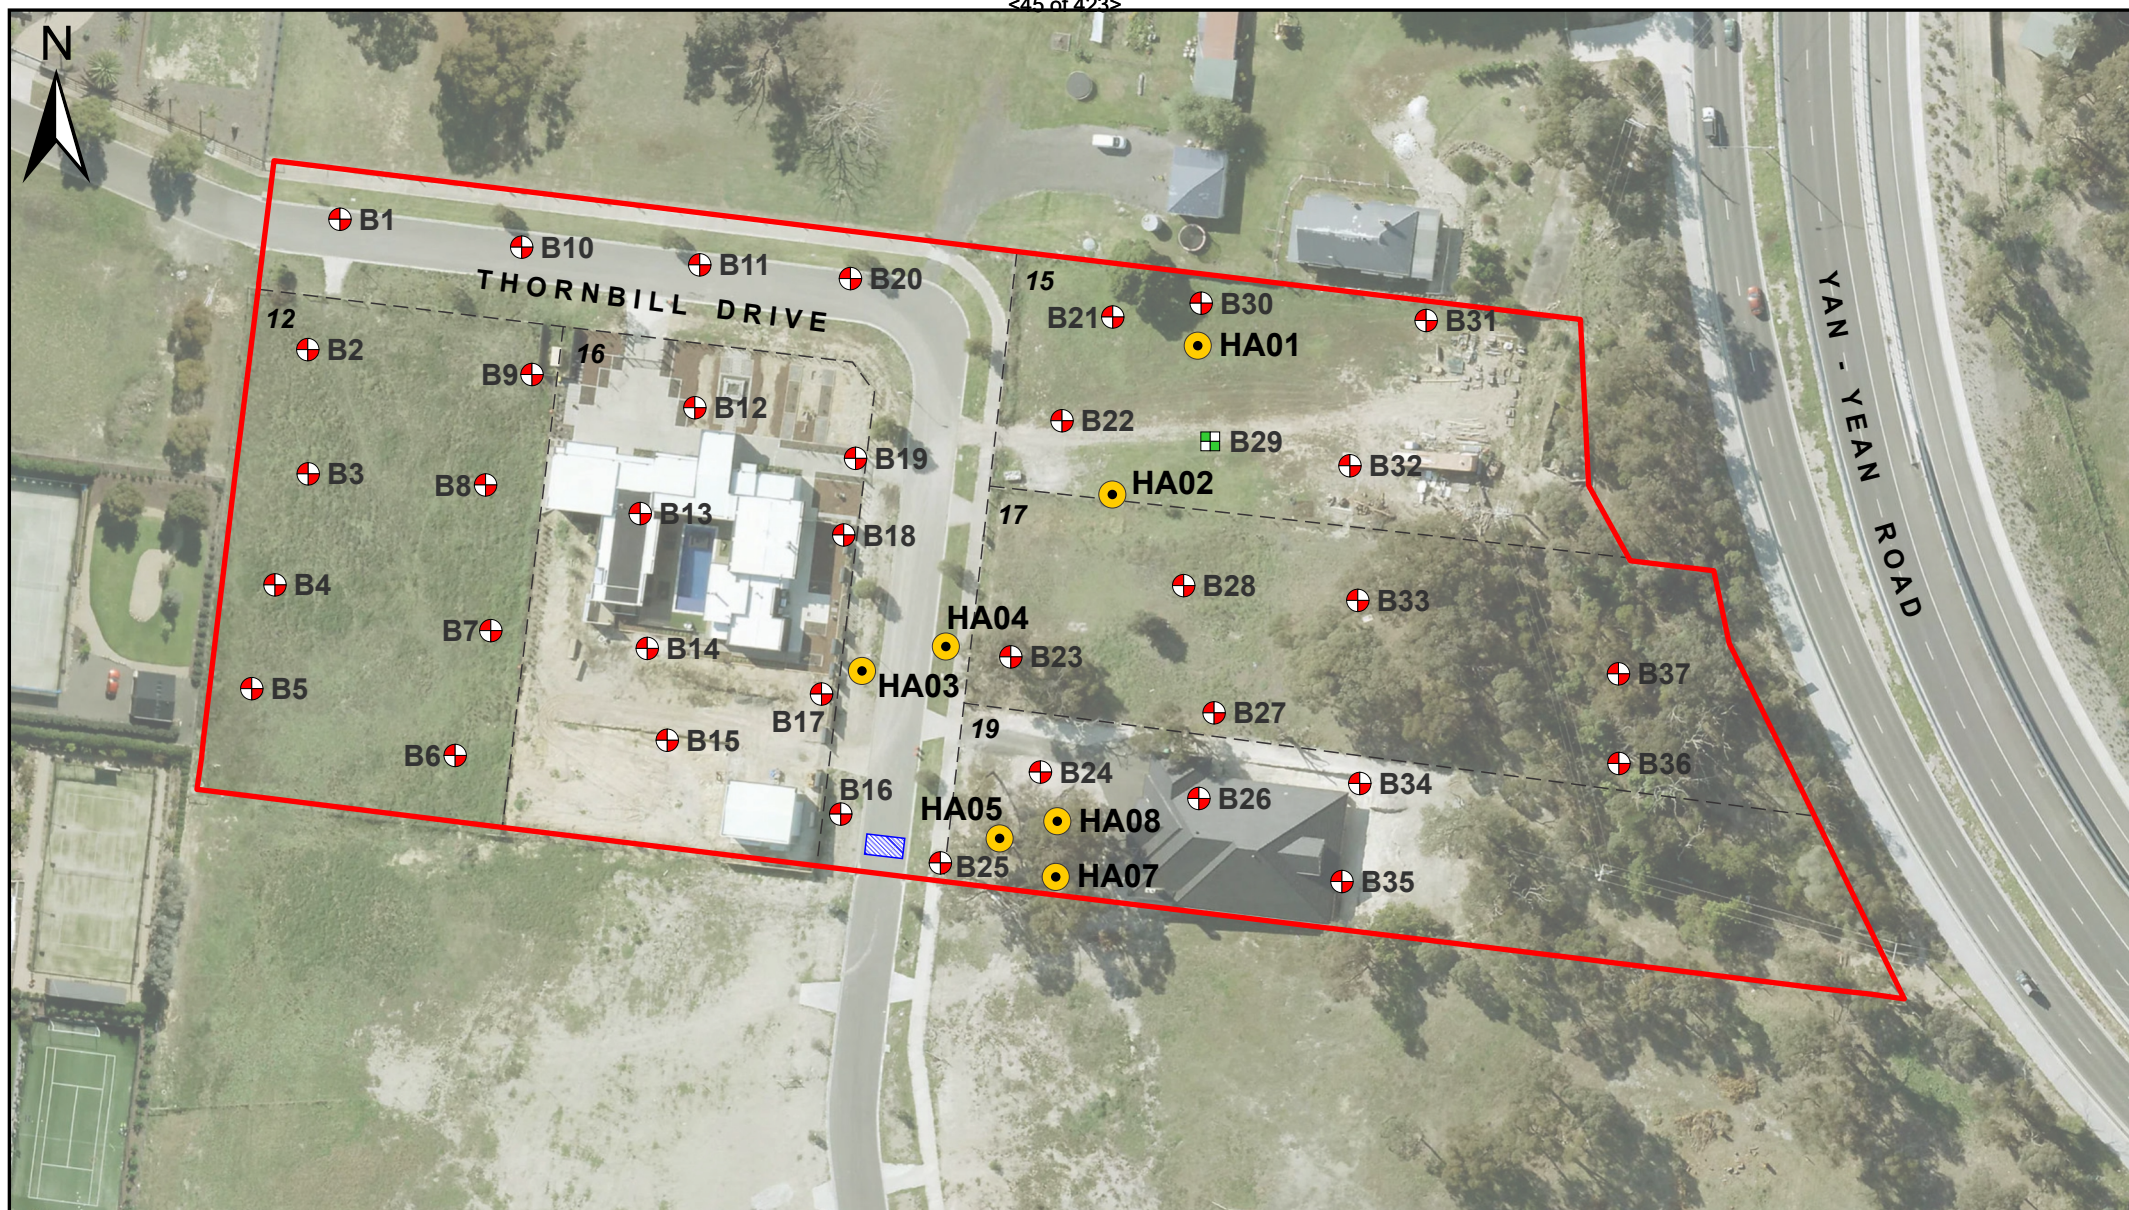
**Figure 2**

- Boreholes were advanced using hand auger to a maximum depth of 1 m below ground level (bgl). Locations are shown on **Figure 2**.
- Soil profiles were logged by a suitably qualified scientist with colour, odour, texture, and material type were noted. Borelogs are provided in **Appendix F**.

The location (refer to **Figure 2**) with the highest level recorded (3.0 ppm) was at the boundary of No. #12 and No. #16, along #16's retaining wall, at the northwest corner of the tennis court. Observed along this location were white PVC pipes to vent air from #16's sewer system. No. #12 is the lowest elevated property and there is a sewer lid at its southwest corner.
