## Preliminary Risk Screen Assessment

605C La Trobe Street, Redan, VIC 3350

28 January 2022

PRSA reference: 280122\_REDAN

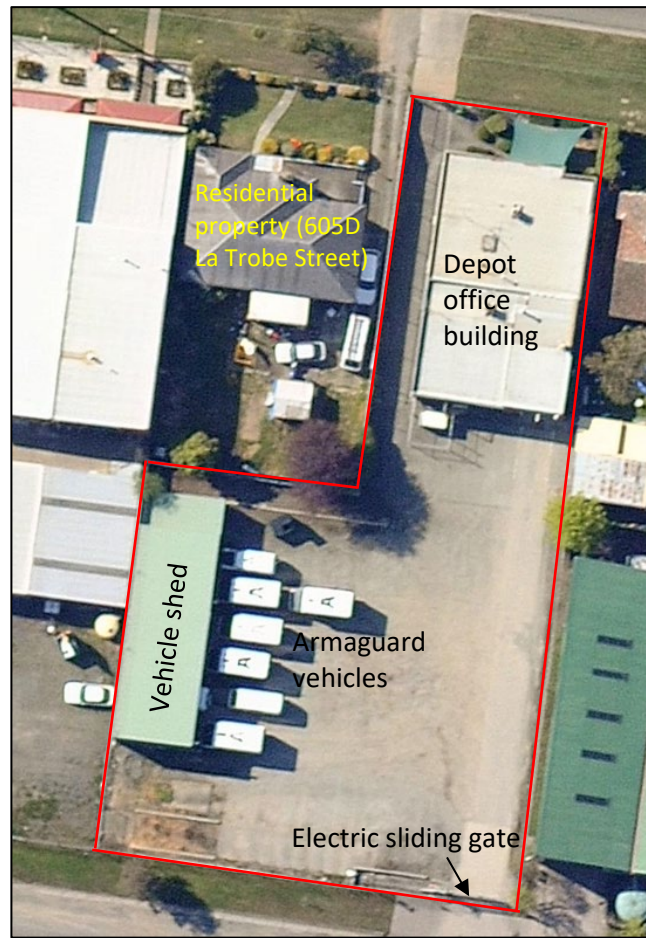
**Plate 2:** Aerial photograph of the site from 2 October 2010 (Source: Nearmap)

Based on the 1975 aerial photograph, it appeared that a building (inferred to be the office building for the depot) was present in the northern portion of the site. Sometime between 1990 and 2004, a shed (with a green roof) was constructed at the south-western portion of the site. That shed was an open parking bay for Armaguard vehicles (see **Plate 3**).

**Plate 2** is an aerial photograph from 2 October 2010 marked up to show previous site buildings. **Plates 3** and **4** are from Google Street View showing the layout of the site when buildings were still present. It is noted that older Google Street View images, dating back to 2007, were reviewed and showed the same layout.

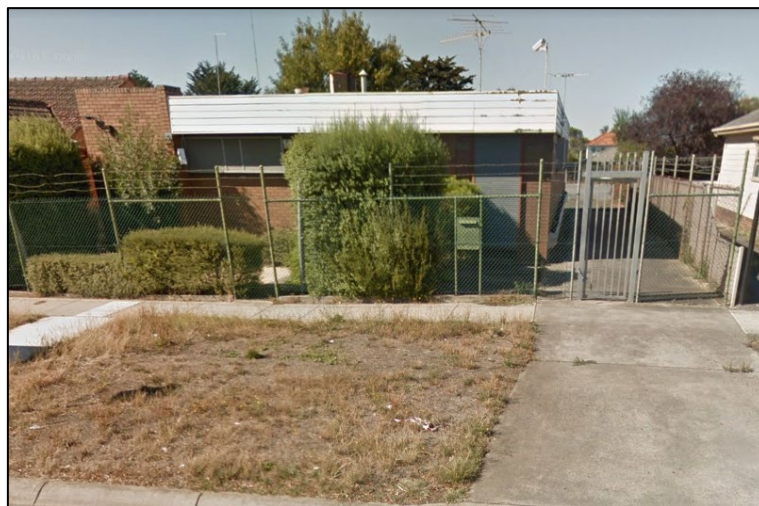
**Plate 3:** View of the Armaguard depot from La Trobe Street, February 2018

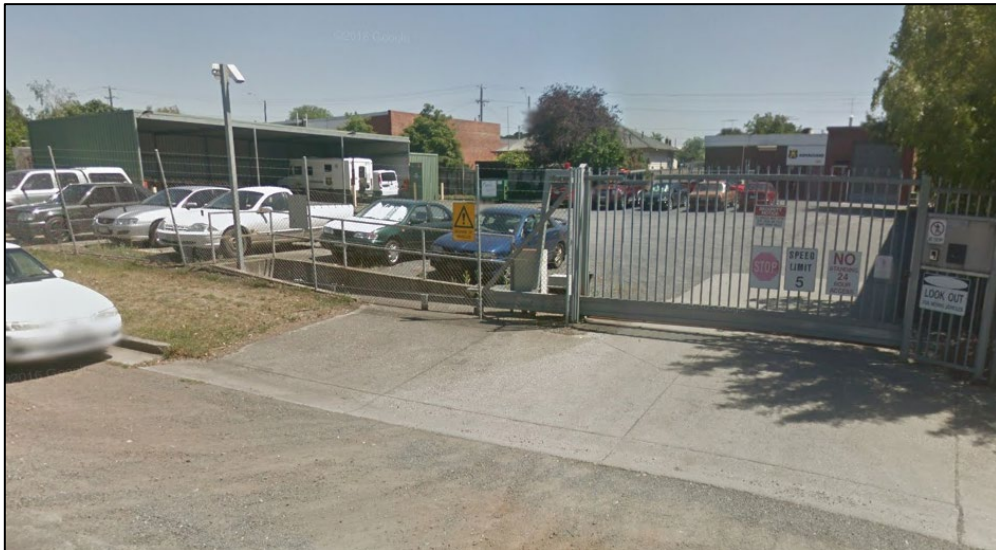
**Plate 4:** View of the car and Armaguard vehicle parking area from Foster Street, December 2014
