Information sheet for environmental audits and preliminary risk screen assessments (PRSAs)

**Preliminary Risk
Screen Assessment**
**179 Gladstone Street, South
Melbourne, Victoria**

Client No: B0267
Job No: 101864M

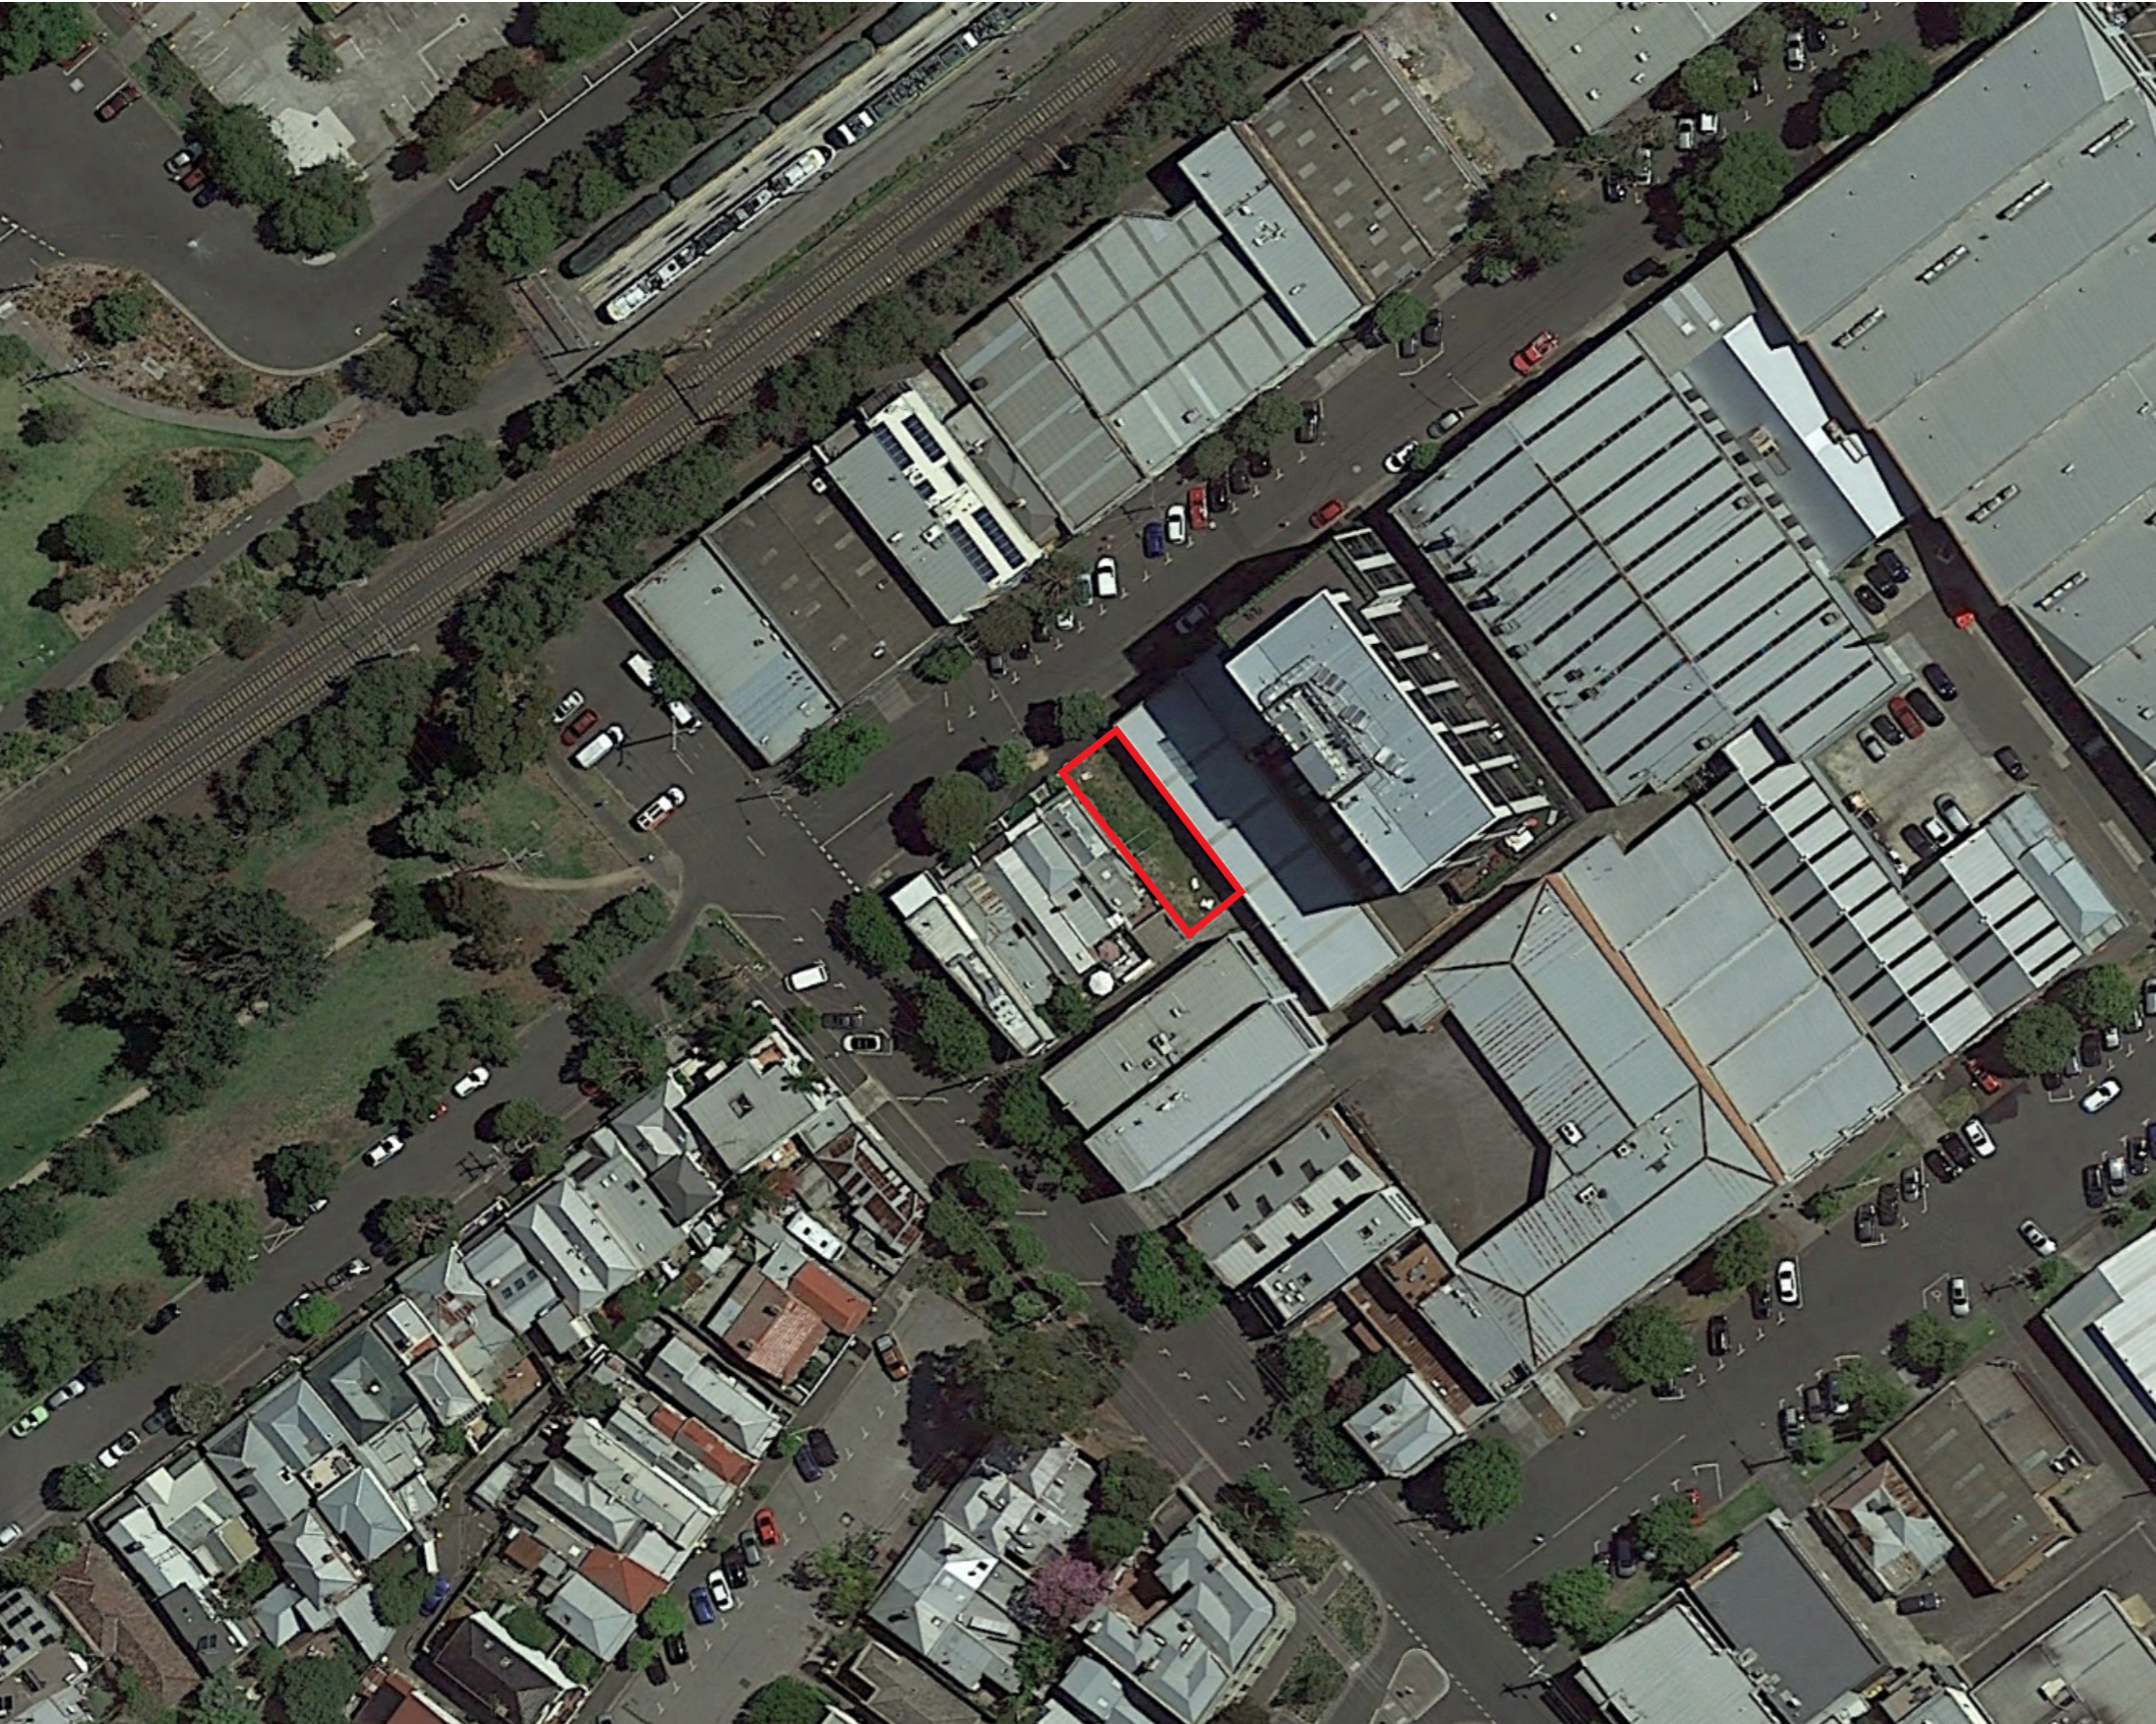
Site Location Plan

Image Source: NearMaps			Viewed: xx/xx/20xx
File Name:	101864M Figure 1		Version: 1
Drawn By:	LJB	Checked By:	TLF
Date:	23/03/2022	Figure number:	1
