Preliminary Risk Screen Assessment

**1936 Healesville-Koo Wee Rup Road,
Yellingbo, Victoria, 3139**

Report No.: 31104.02

Site / Premise name	Former Yellingbo Primary School

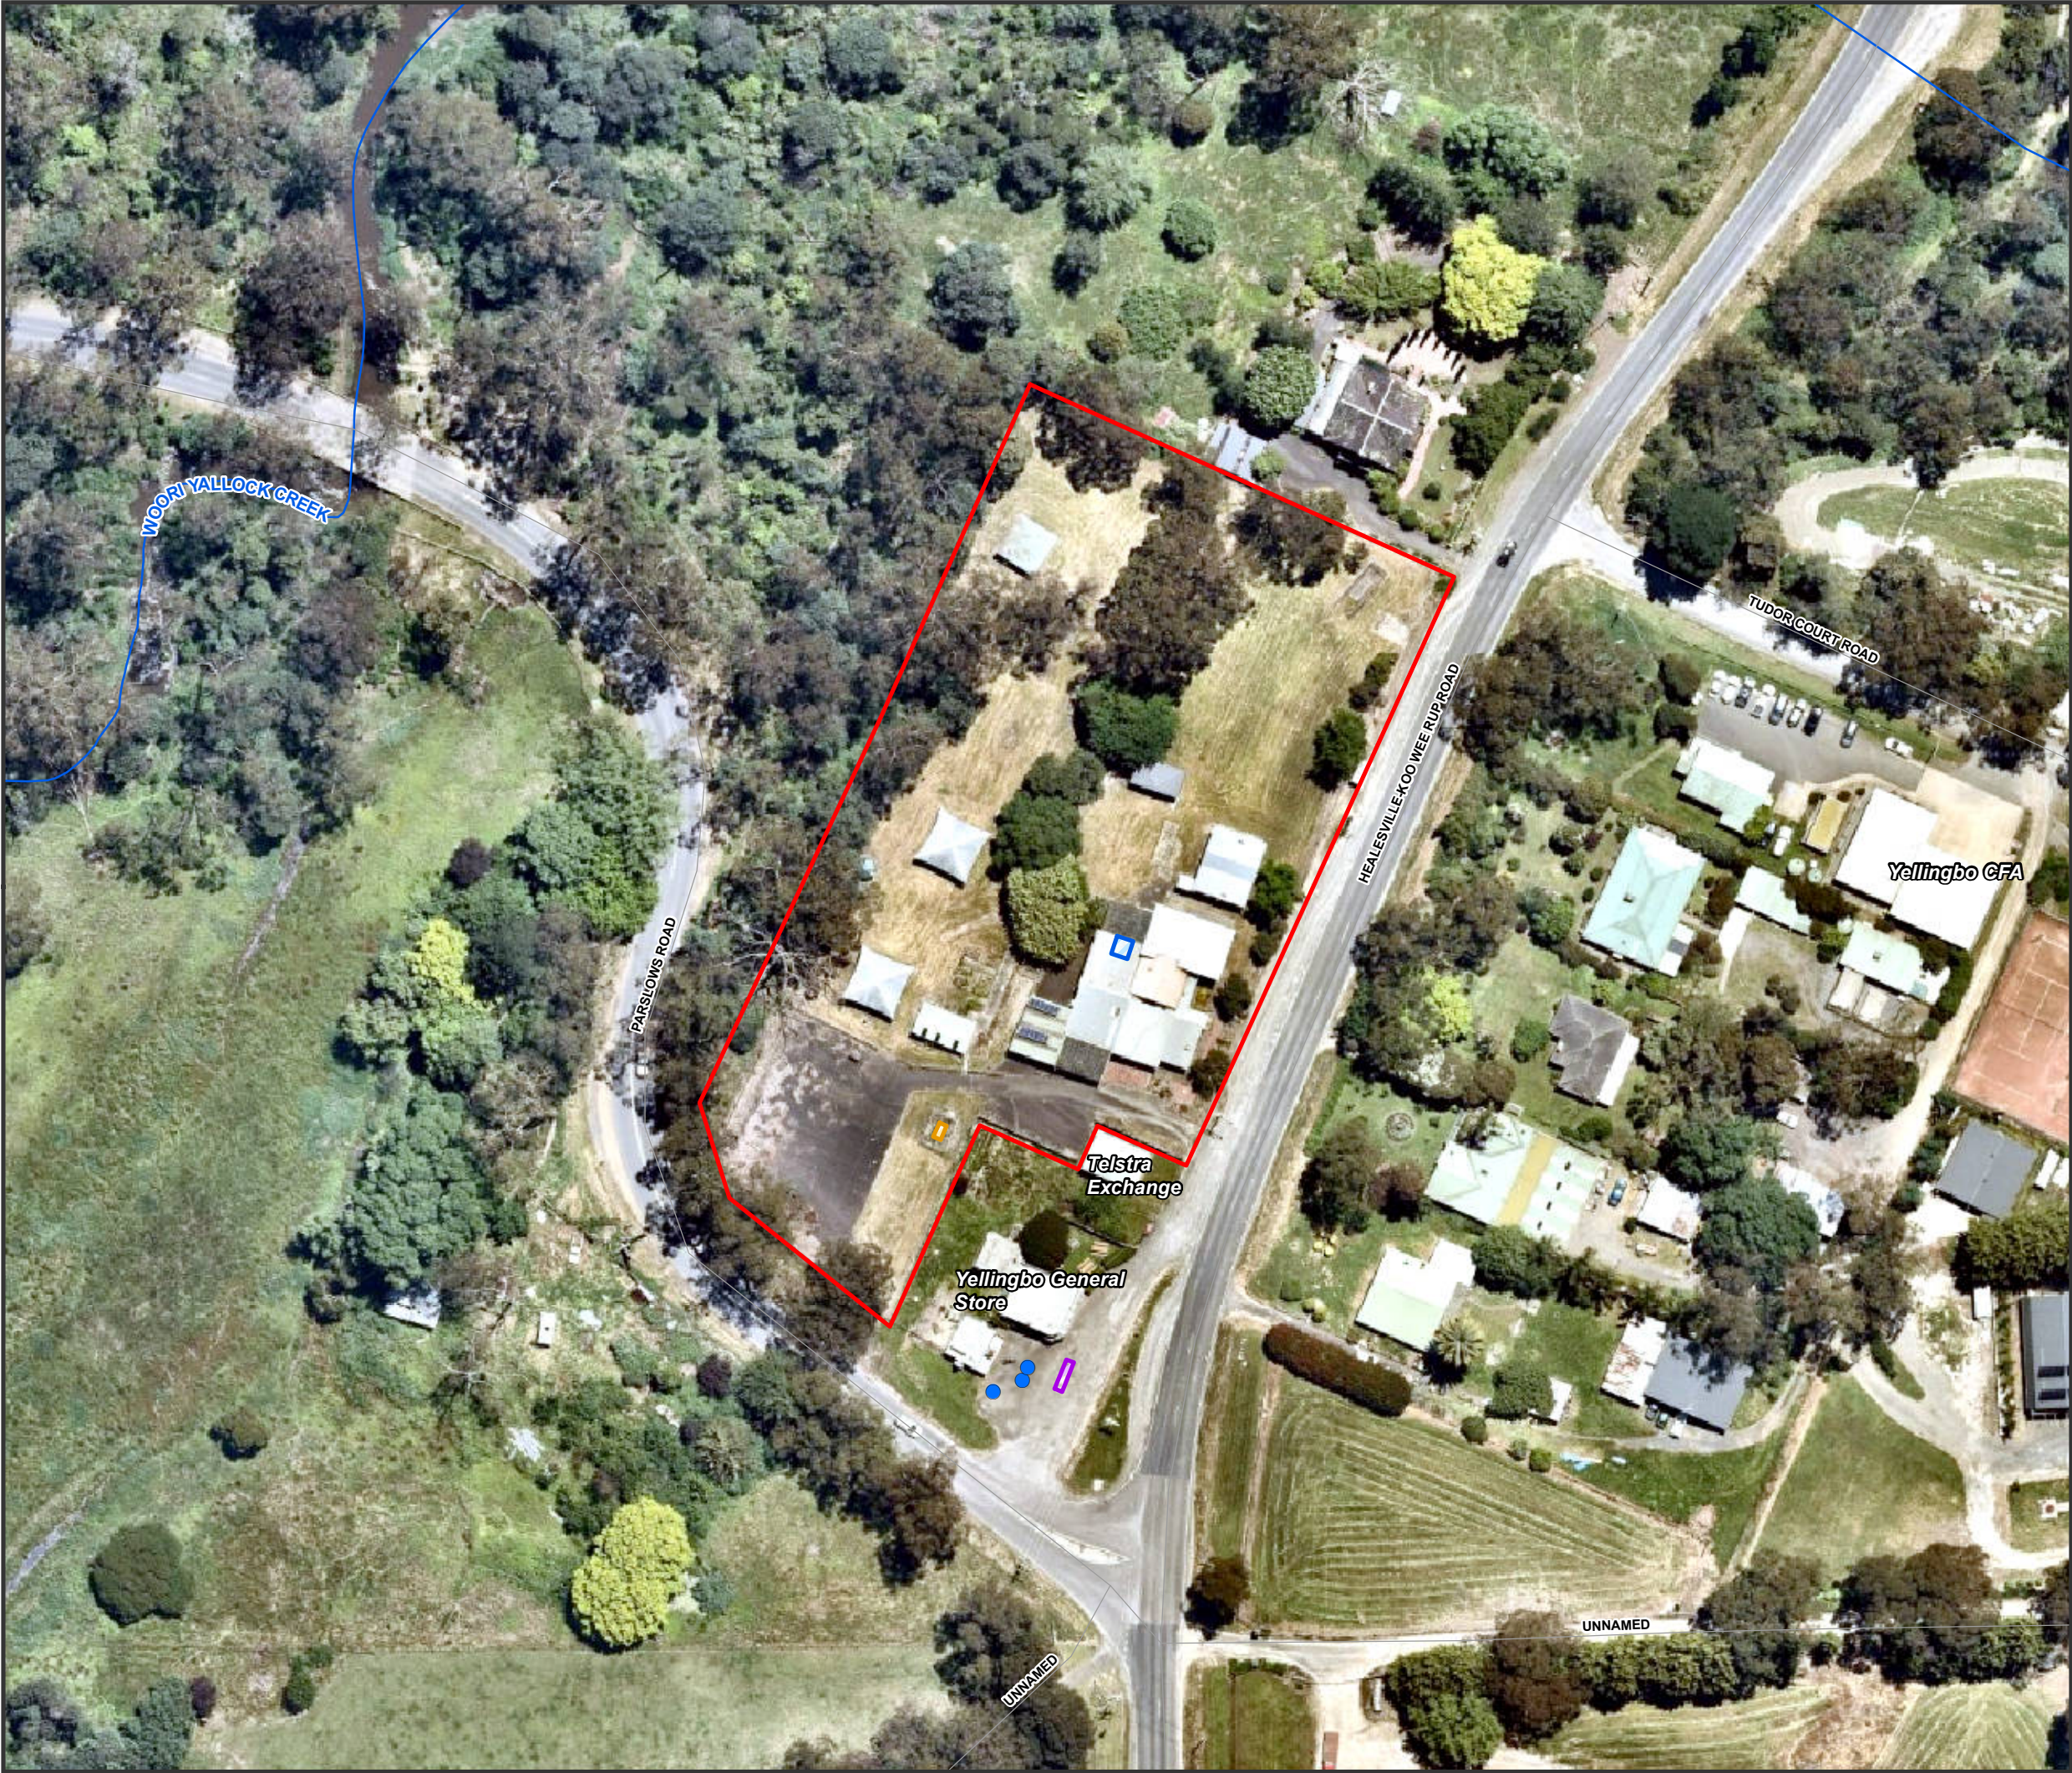
A Site inspection was completed on 18 March 2022 by the Auditor, Dr Darren Bennetts and assistant, Brigitte Small. Observations made during the inspection are provided in **Table 8** below. Observed Site features are presented on **Figure F2** and photographs are provided in **Appendix C**.

LPG UST

UST fill / dip point
