Preliminary Risk Screen Assessment

**Former Seaton Heyfield Primary School
Plantation, Schoolhouse Lane, Seaton,
Victoria**

23 May 2022

Report No.: 31105.01

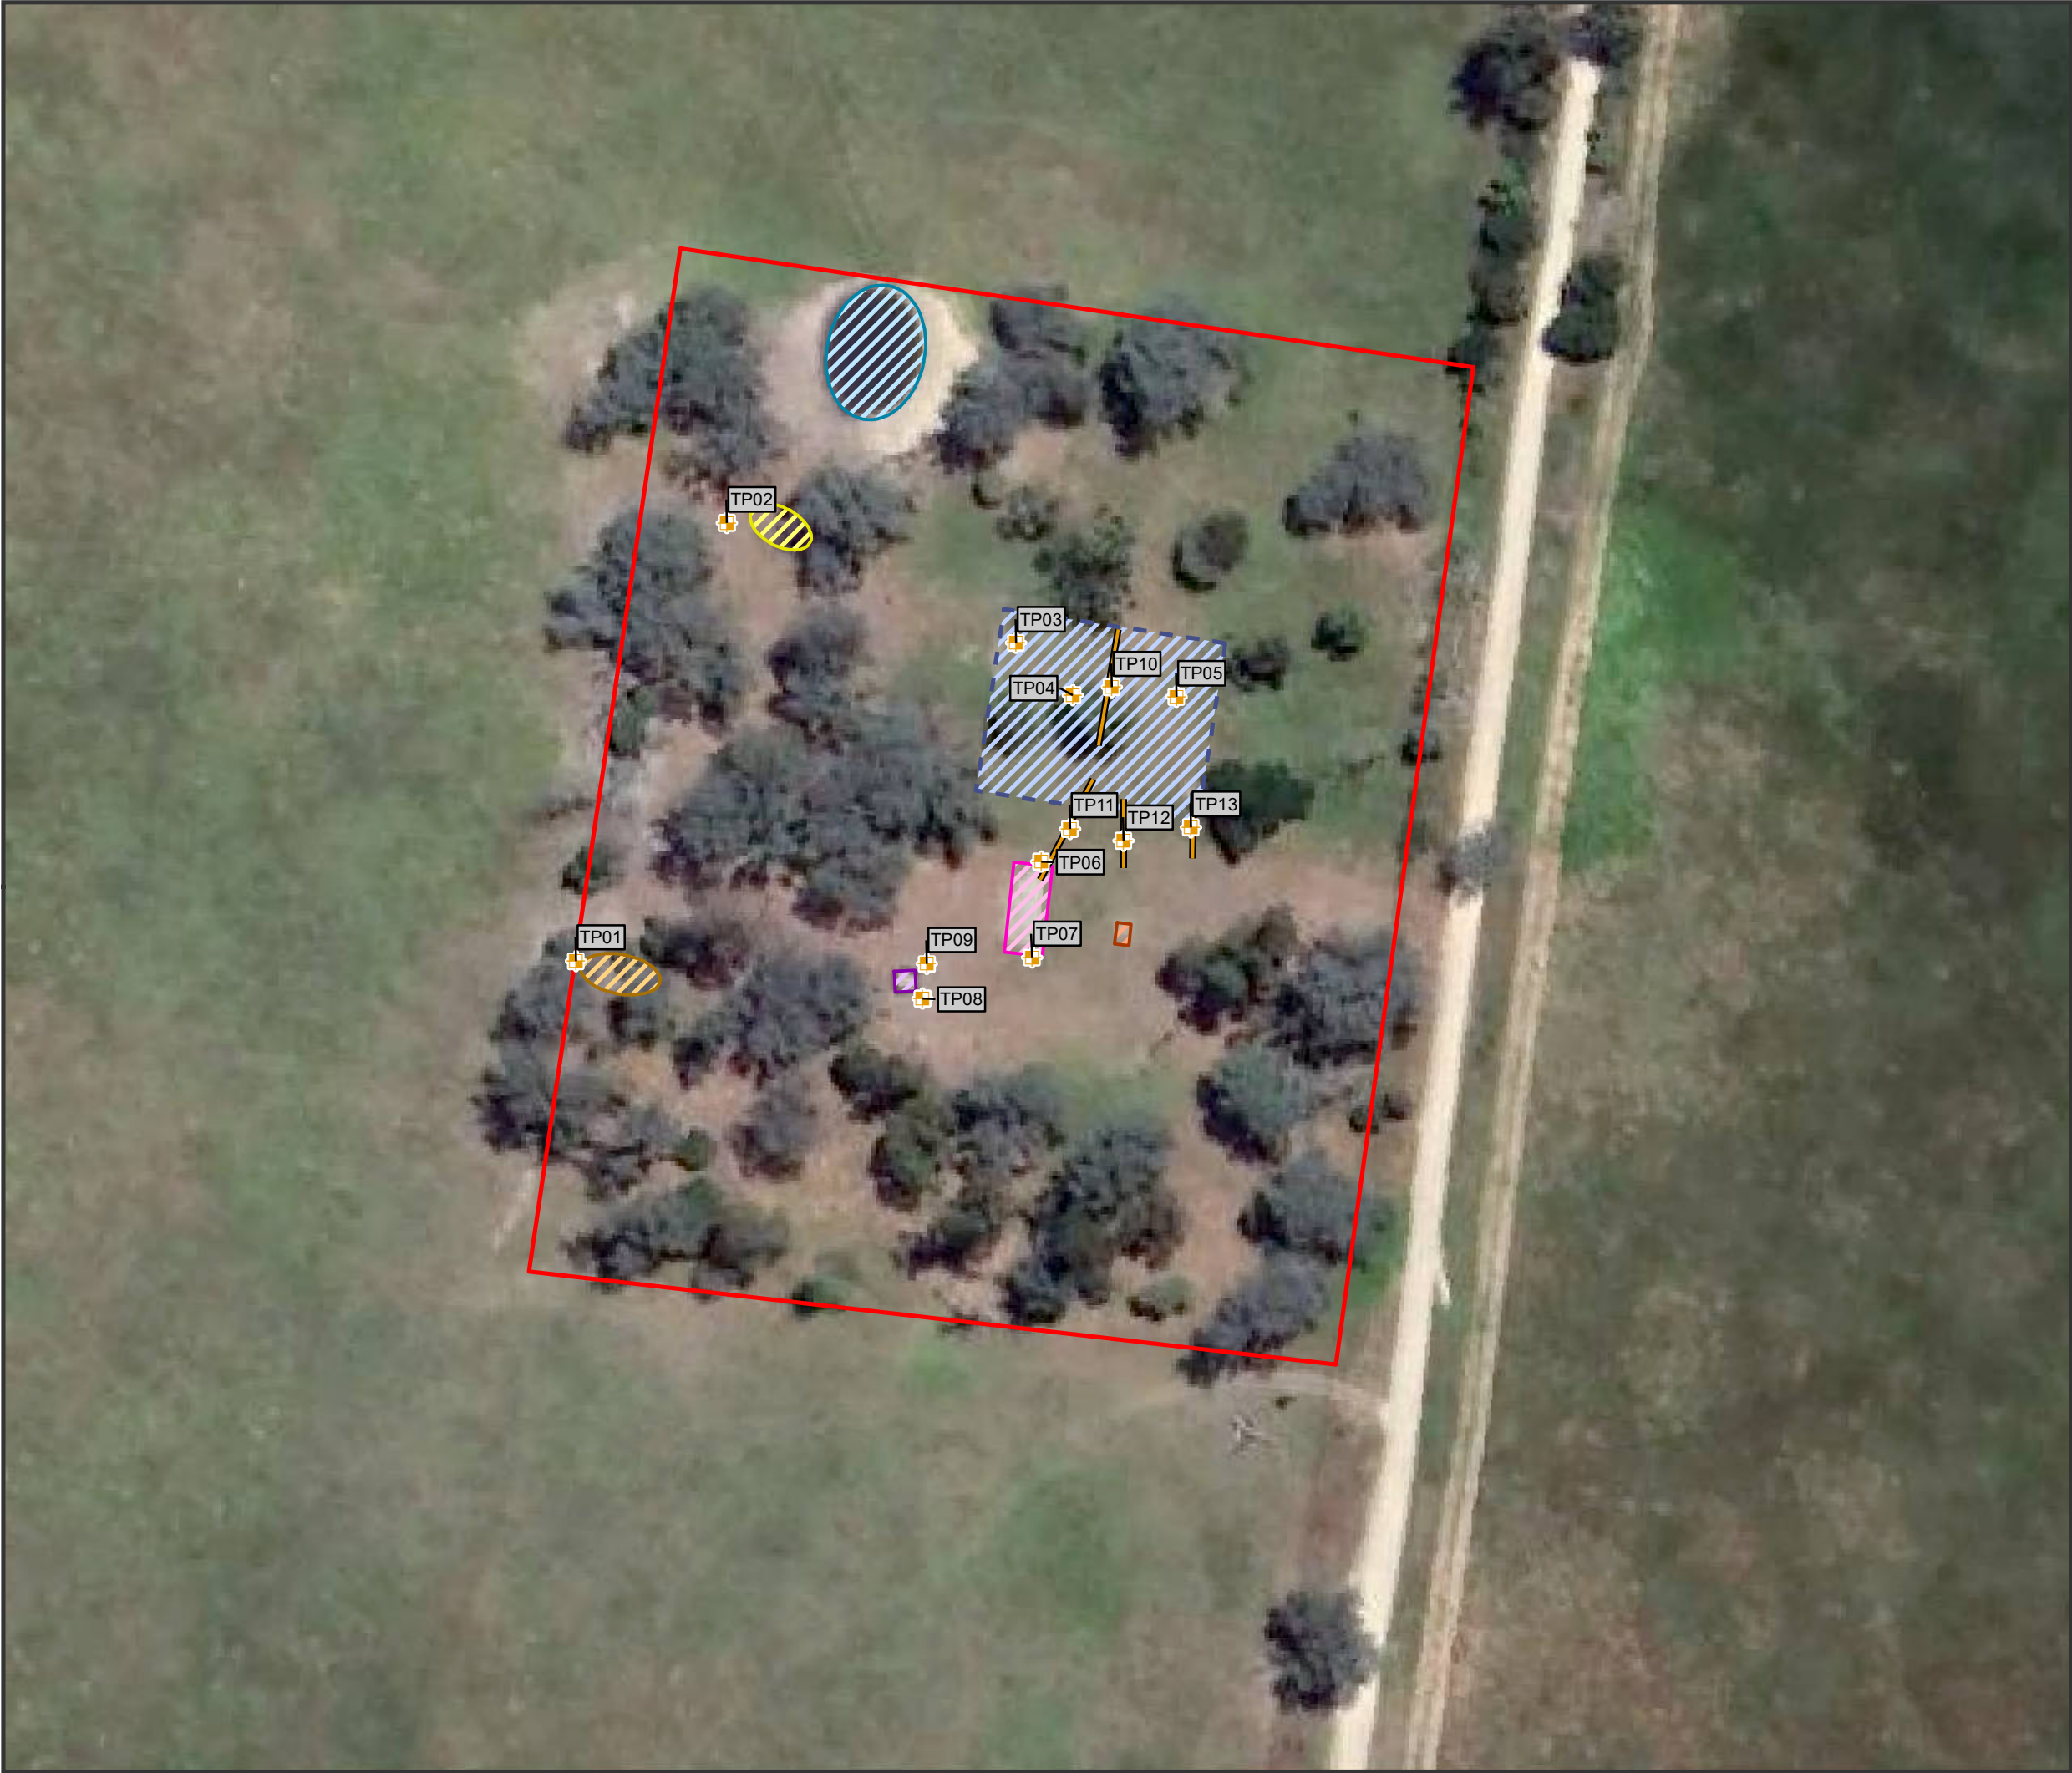
Figure
F1

A Site inspection was completed on 18 March 2022 by the Auditor, Dr Darren Bennetts and assistant, Brigitte Small. Observed Site features are presented on **Figure F2** and photographs are provided in **Appendix E**. Overall the Auditor’s observations accord with those of SLR, apart from the following:

- The dam located in the north western corner of the Site had a layer of algae during the time of the inspection and a slight stagnant / ammonia odour. There was evidence of cattle defecating in the water which is the likely source of the water quality issues observed.
- A pile of plastic was located around a dead tree along the western boundary.
