Recycled Water Health & Environmental Management Plan

Draft Report

Lakeshore Caravan Park

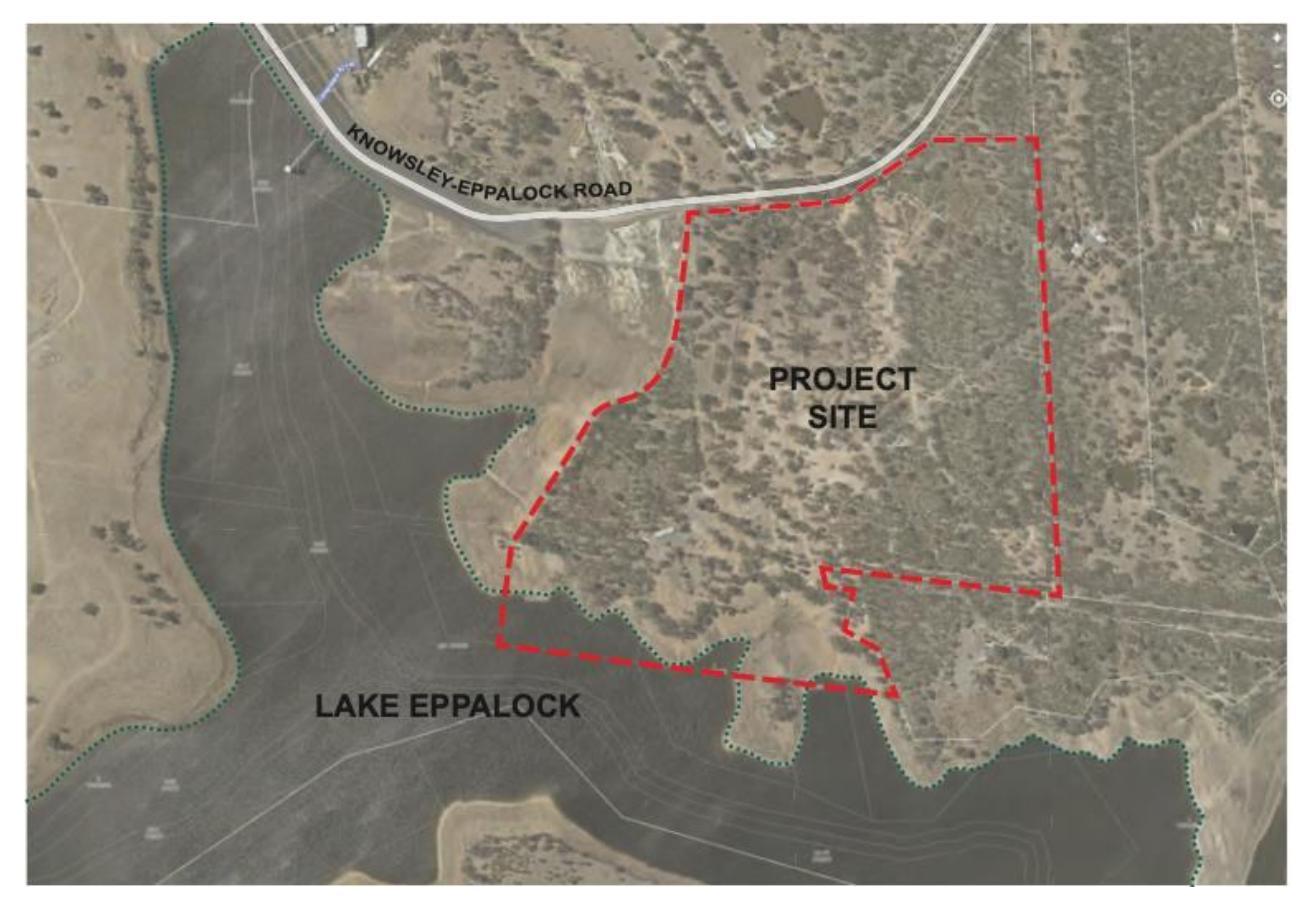
Figure 1-1: Lakeshore Caravan Park site

The proposed redevelopment of Lakeshore Caravan Park is located at 655 Spillway Rd, Lake Eppalock.

A map for the site is provided in Figure 1-1.

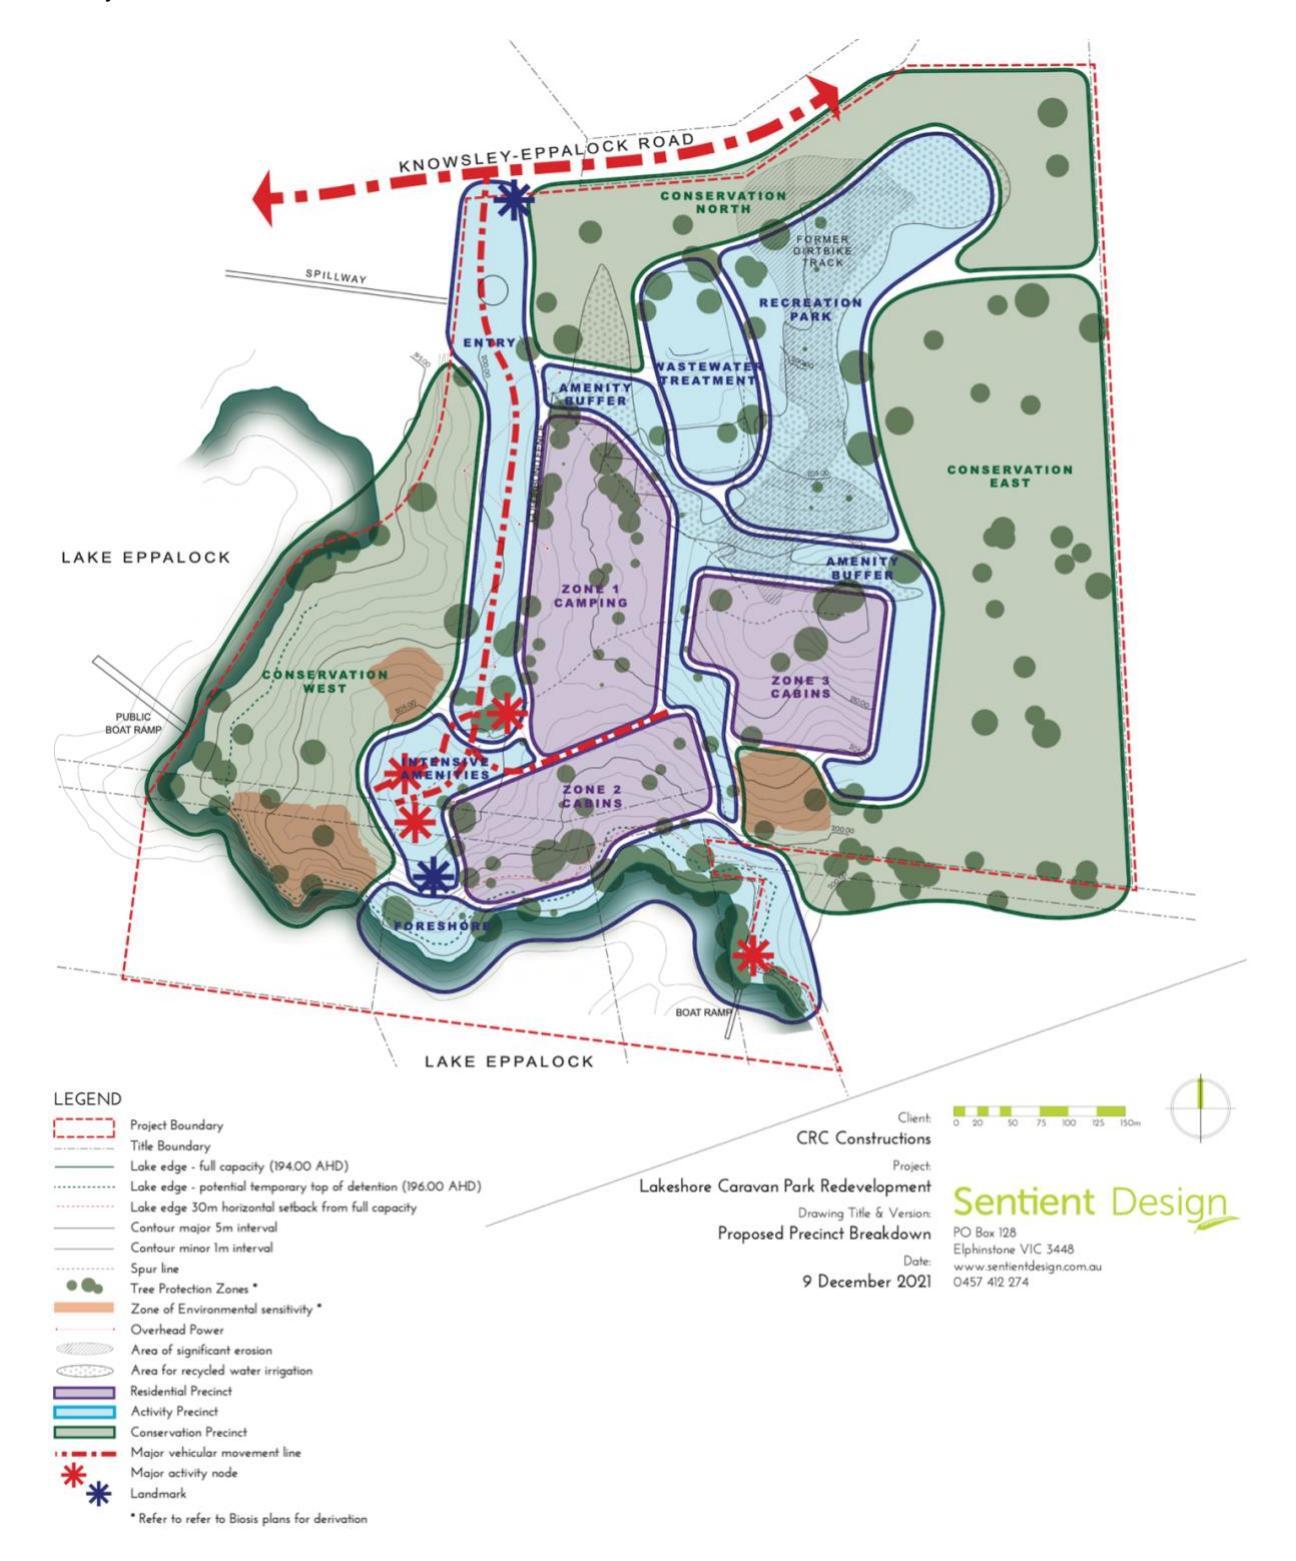
Figure 4-1: Site layout (Sentient Design 2021)

Figure 4-1 shows the layout of the site, including the wastewater treatment area (which includes the storage dam), and the area to be irrigated with recycled water, which includes sections of the recreation park and the amenity buffer.

Areas of the site which contain high quality habitat will not be irrigated with recycled water. Recycled water will only be applied via sub-surface irrigation to grassed areas within the recreation park and amenity buffer area as shown in Figure 4-1.

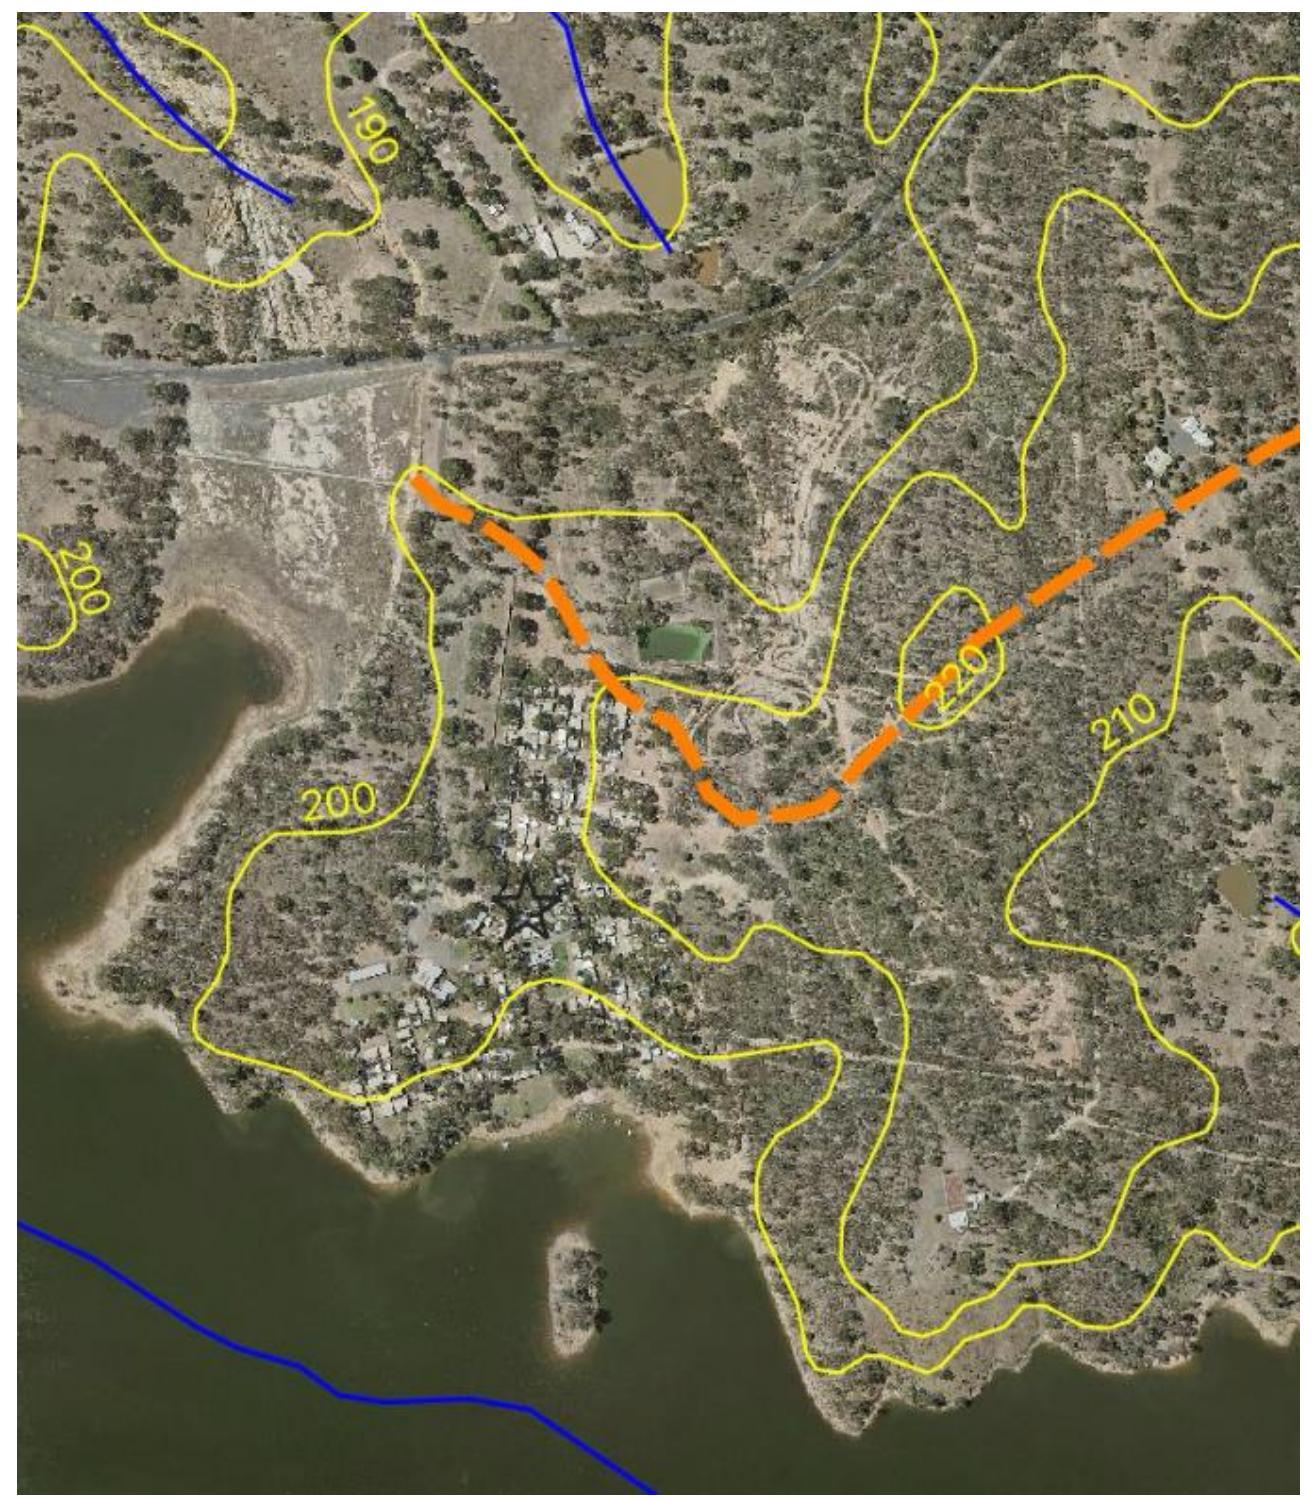
Figure 4-2: Ridgeline denoting catchment boundary for Lake Eppalock

There is a ridge running through the site as shown in Figure 4-2. Areas to the north of this ridgeline drain away from the lake. A significant portion of the recycled water irrigation will be targeted to areas north of the ridgeline as it is outside the catchment area of Lake Eppalock.

Slopes are gentle on the ridge areas (approximately 0-10%) with steeper areas towards the water edge and along the northern gully (approximately 10-15%). Former site uses have caused alterations to the natural land surface, also altering surface hydrology.

The sites topography will not restrict the use of recycled water. Irrigation will be confined to areas which drain away from Lake Eppalock. Recycled water will be applied below the soil surface reducing any runoff.

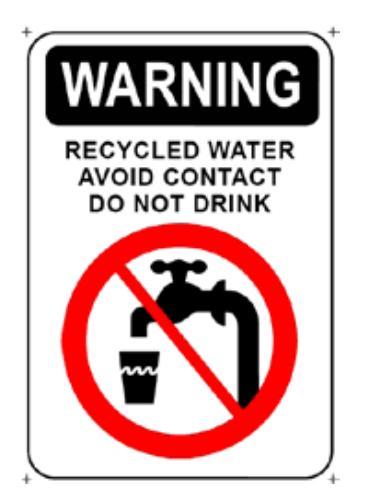
Figure 8-1: Example of recycled water warning signage

Signs (similar to the example in Figure 8-1) will be in place to alert staff and caravan park guests to the use of recycled water. They will be located at site entrances and on the storage dam fence. They will be checked periodically to ensure they are visible and in good condition.

Irrigation infrastructure that is above ground and in areas of public/guest access will be distinctively colourcoded (deep purple) and/or marked with the words: WARNING: RECYCLED WATER - DO NOT DRINK.
