COMMUNITY INFORMATION

EPA ASSESSMENT OF LICENSED LANDFILLS: CLAYTON SOUTH AREA

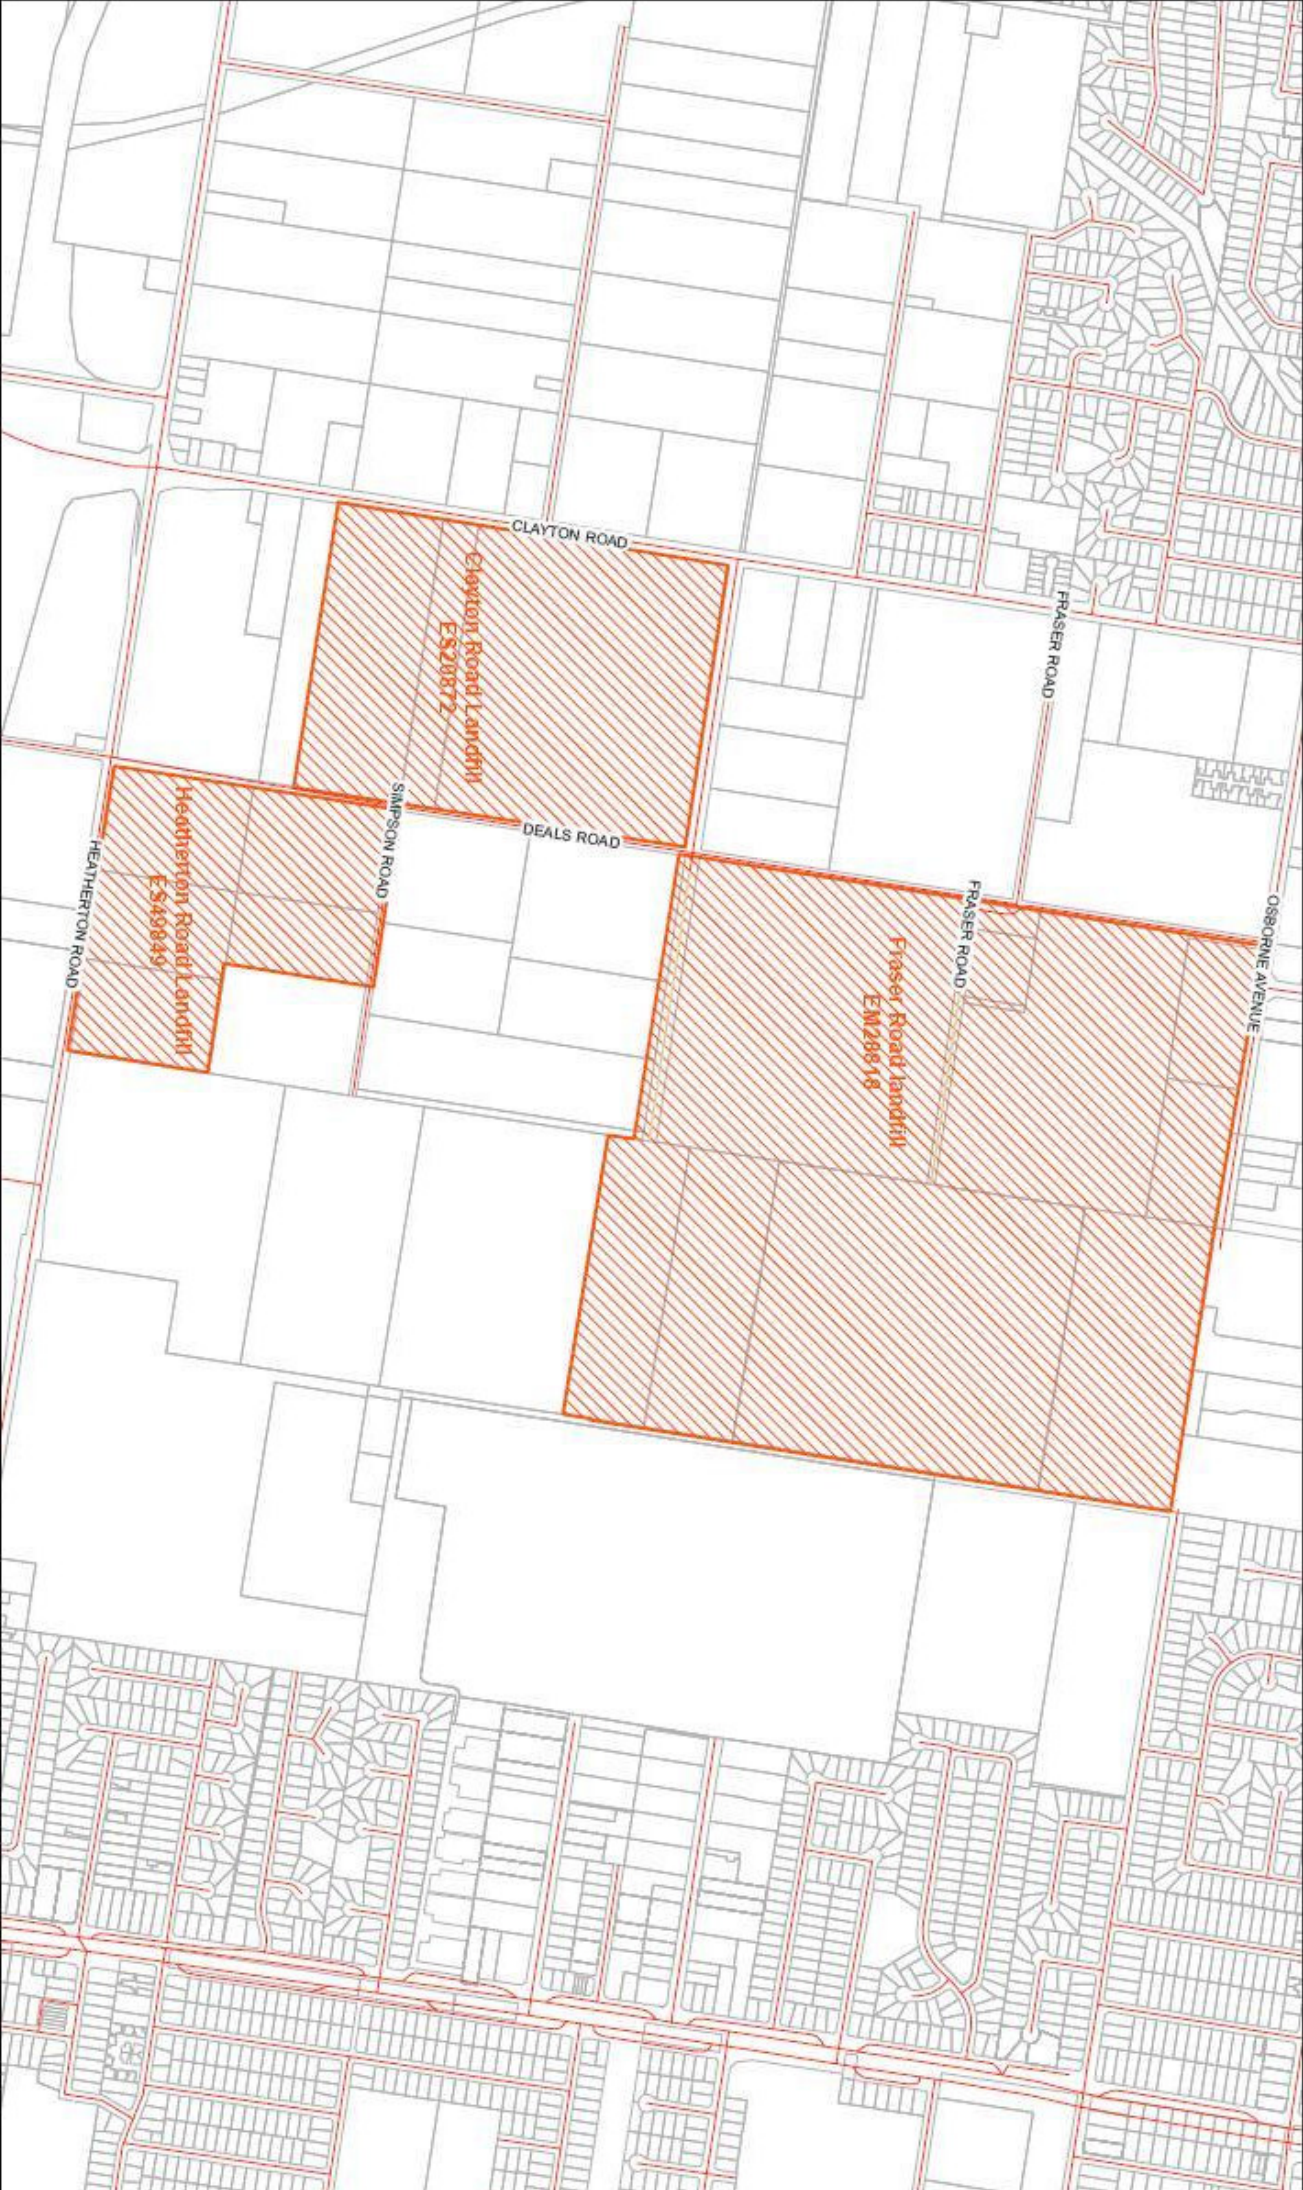
Landfill Sites in the Clayton South Area

In the Clayton South area (see map), EPA identified three landfills that require methane management works by the operators to monitor and stop methane movement. These landfills are located on Fraser Road, Heatherton Road and Clayton Road respectively. Methane was detected at the boundary of each of these landfills, at concentrations above one per cent.

Disclaimer: Only EPA licensed (and former licensed) landfills where methane was detected >1% v/v adjacent to the site are shown. The landfill site boundary reflects the boundary of the site itself, waste deposits will be present within these boundaries, commonly distributed in zones. Other landfills may be present in this area but are not shown on this plan. The extent of the plan is for context only, and should not be interpreted as the extent of methane gas movement. Suburbs surrounding these landfill sites have not been affected by methane.

- Landfill operators have offered methane monitors or onsite gas monitoring bores to the occupiers of the homes, plant nurseries and other industrial buildings whilst gas management works are completed.
- Onsite gas extraction systems are being improved by operators.
- Boundary gas monitoring bore networks are either being upgraded or installed by operators.
- Operators are installing landfill gas cut-off trenches to intercept gas escaping the landfill.
- Operators have engaged EPA-approved environmental auditors to conduct an environmental audit.
- EPA has required a gas management plan from the operators, with regular updates reported to EPA.
